Section 2

**CONCRETE GRAVITY
DAMS**

by Jerome M. Raphael

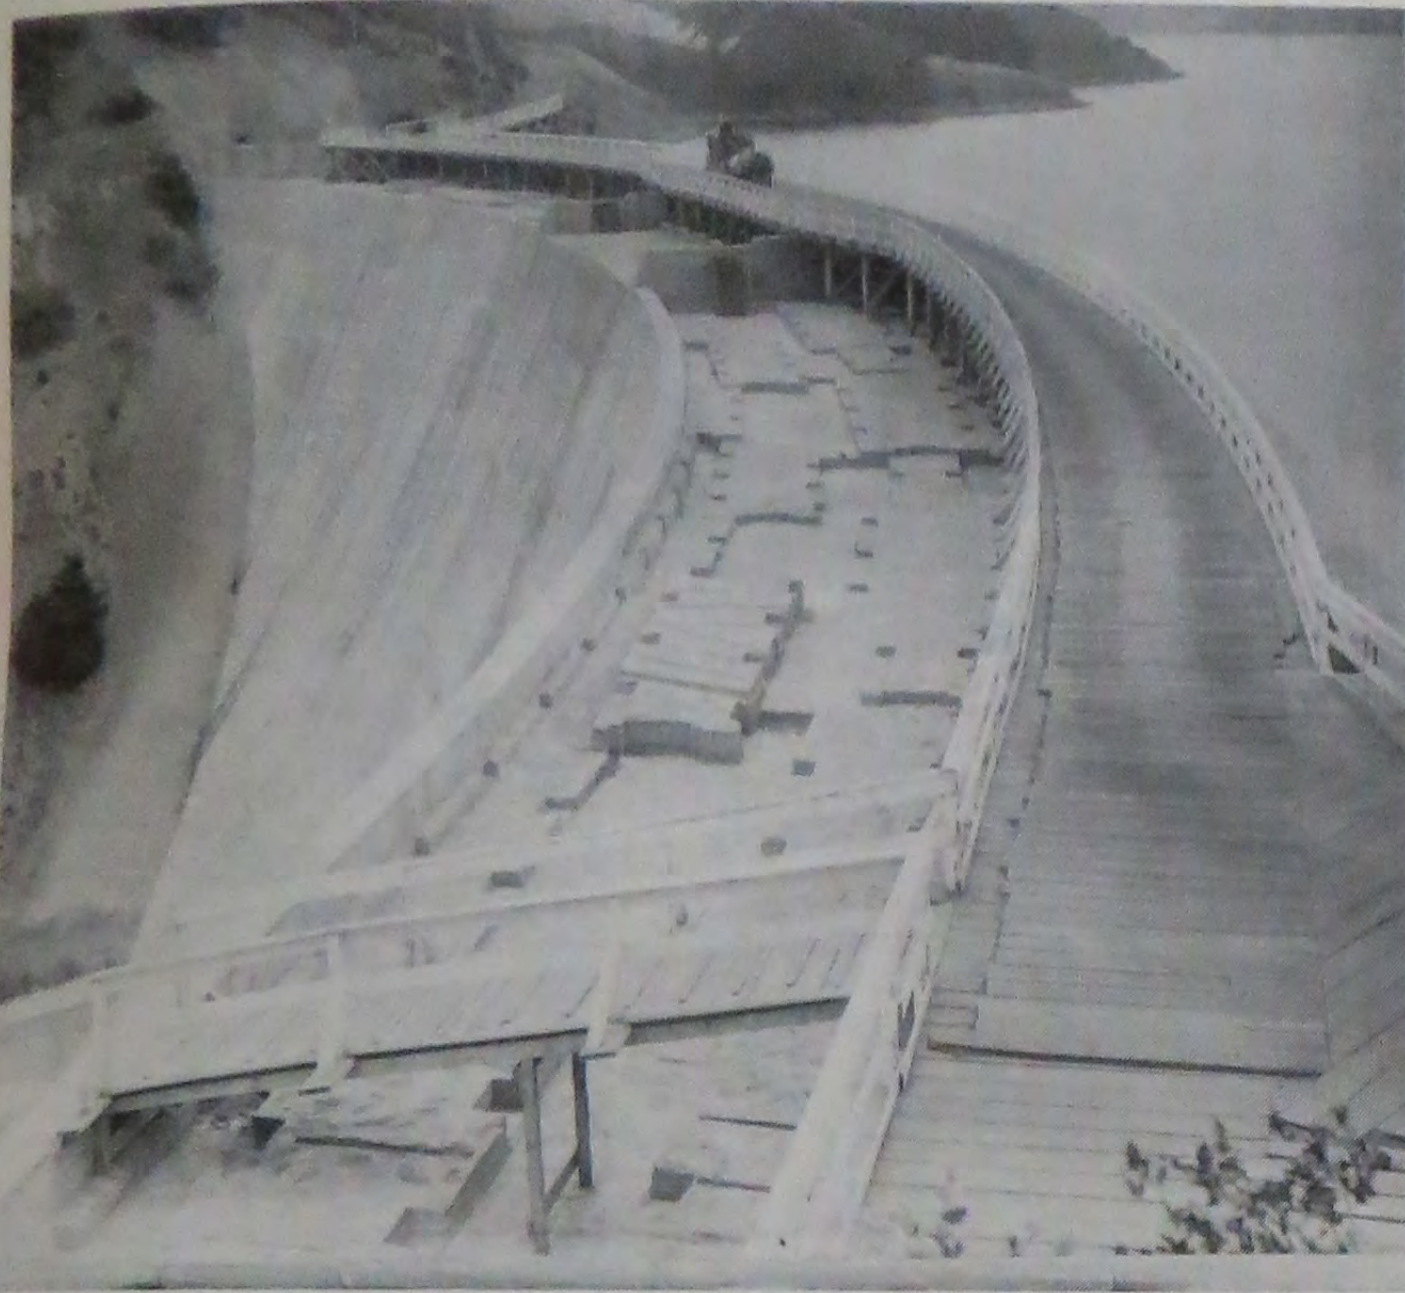
Figure 2-4 Photo of crest—Lower Crystal Springs Dam
