A Man, A Dam and A Disaster: Mulholland and the St. Francis Dam

by *J. David Rogers*

St. Francis Dam Disaster Revisited

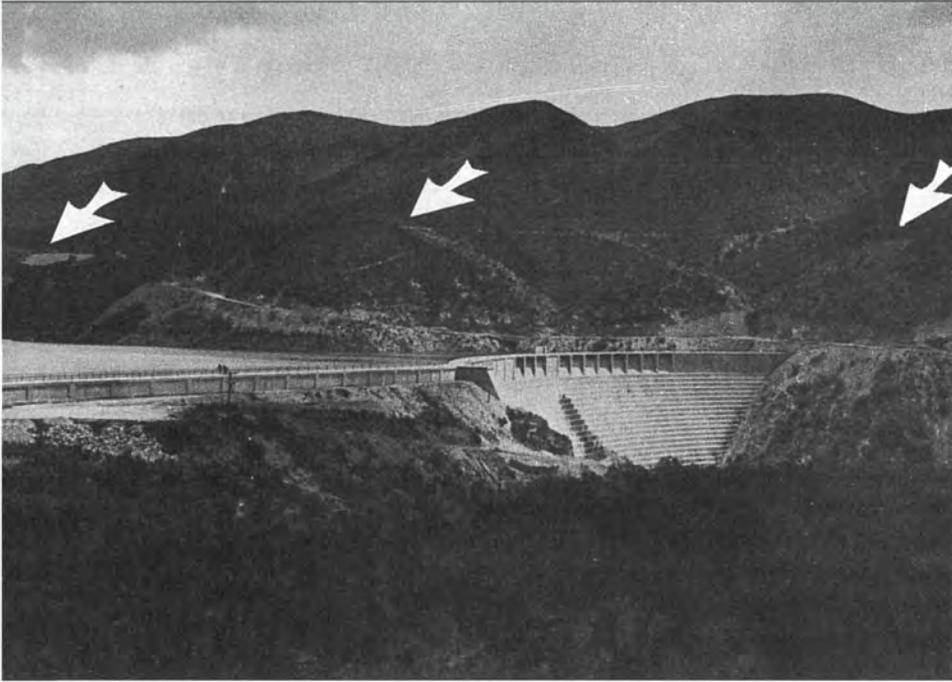
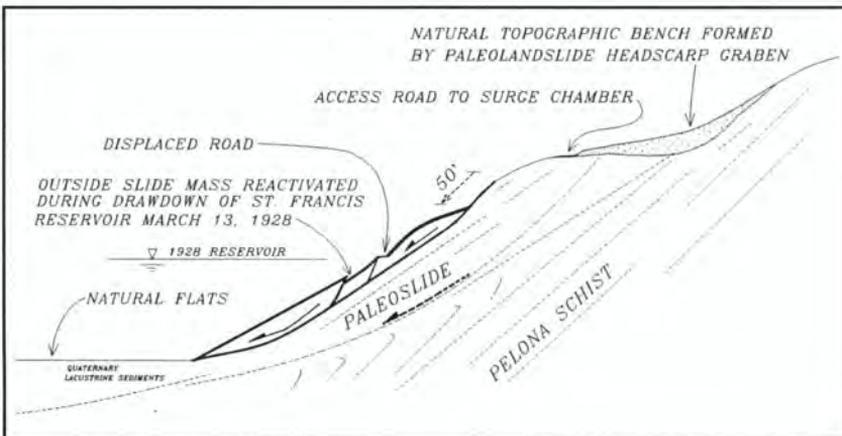
FIGURE 1 - 1927 view looking upstream at St. Francis Dam and reservoir from a knoll in the Sespe sandstone. The main dam section built within San Francisquito Canyon is seen at right. San Francisquito Canyon Road can be seen just above the dam's far abutment, about 10 to 15 feet above the dam crest. The long dike section lies atop a bedrock spur at center picture, while the auxillary spillway weir crosses the small saddle in left foreground. Mulholland's Franklin touring car sits atop the ridge, to rightmost of the three vehicles, and the "Chief" appears to be walking the crest of the dike at right center. The arrows indicate the topographic bench formed within the Pelona Schist by ancient megalandslides. A geologic cross section through this slope is shown below.

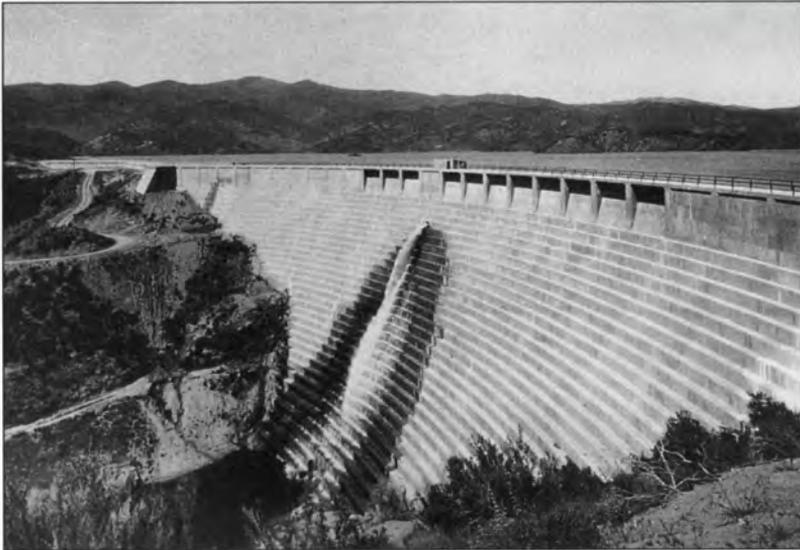
Figure 2 - St. Francis Dam as it appeared just after its completion in May 1926. It was a curved concrete gravity section, standing approximately 200-feet high and was comprised of 130,000 cubic yards of concrete without benefit of any contraction joints, drainage galleries, cut-off walls, or grout curtain. The Pelona Schist made up the east abutment, on the right side of the photo, while the Sespe formation red beds comprised the upper two-thirds of the west abutment (shown at left). Photo from Huber Collection, University of California Water Resources Center Archives, Berkeley.

The dam structure was completed in May 1926, as shown in Figure 2. The main section across San Francisquito Creek was designed as a free-standing gravity section. Limited seepage relief was afforded in the design, and only a few uplift relief wells beneath the central core were employed (Figure 3, upper). In addition, no

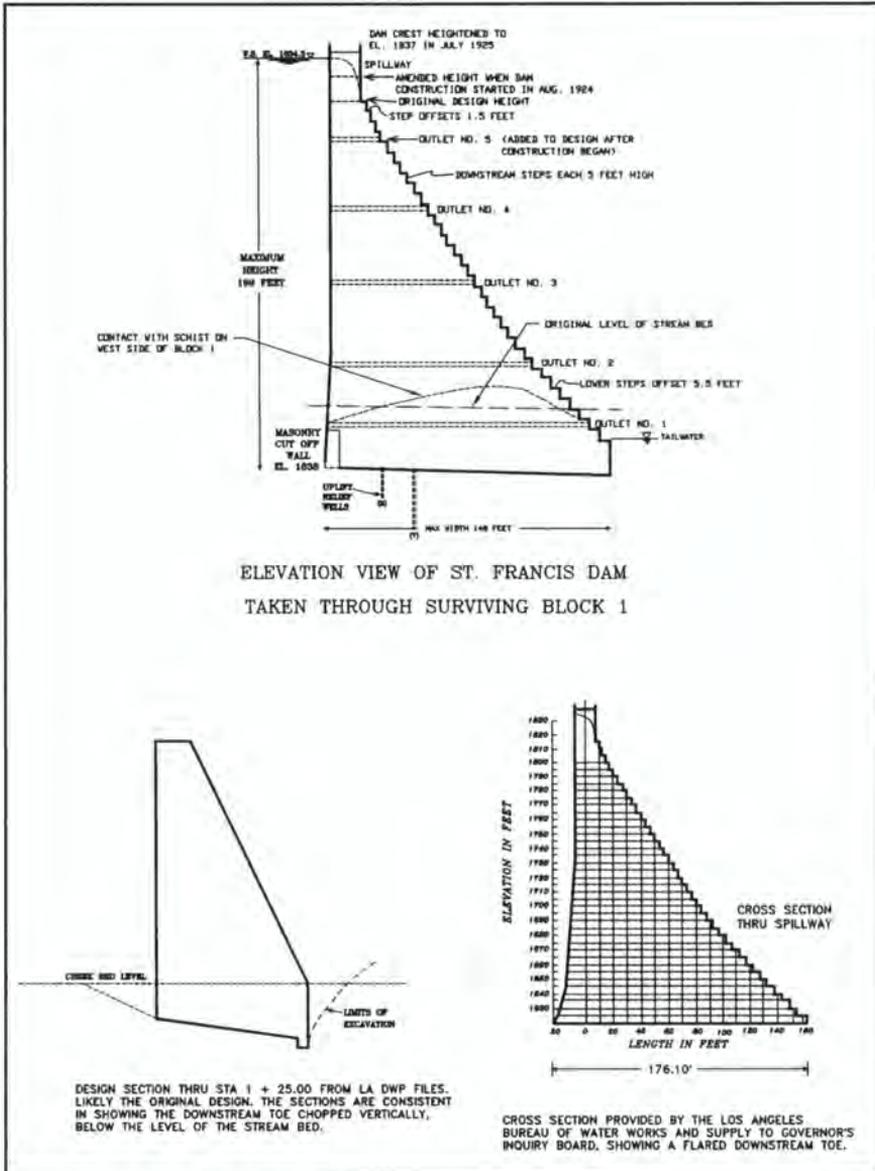
Figure 3- Cross sections of St. Francis Dam through the outlet works contained in Block 1, the only section of the main dam to survive the failure. The upper section is a reconstruction by the author. Some uplift protection, in the form of relief wells, had been provided for the central core of the dam, within the stream channel. No such protection was afforded to the sloping abutments. The section at lower left is from the design sections for the original dam, made in 1923. The section at lower right is that provided by the Bureau of Water Works to the Governor's Board of Inquiry following the failure. Note the variance in maximum base width between these representations. It is unlikely that the dam was as wide as portrayed to the public, although the variance may have been unintentional, given the rush with which the drawing at the lower right was produced.

Most of the post-failure investigative panels would cite the general absence of measures to reduce seepage forces underneath the dam, causing the dam's resultant thrust to lie within the downstream third of the main dam block (Figure 3 upper). These would have included such features as a deep cutoff wall/trench, a grout curtain to inhibit underdam seepage, and uplift pressure relief wells (of which there were 8 placed beneath the main portion of the dam, which did not fail). These features became requisite components of masonry dam design a few years later (Creager, 1931; Henny, 1932, 1934; Houk, 1932; Creager, 1934, 1941; Harza, 1935, 1949; Subcommittee, 1952). In the aftermath of the dam's failure, some stinging criticisms of the city's lack of appreciation for the detrimental effects of uplift pressures were also voiced by some prominent dam designers of that era (Bennett, LaRue, Moore, Wiley, Fowler, Ledoux, Grunsky, Gerry and Jorgensen, all 1928; Terzaghi, 1929; Floris, Grunsky and Morris, 1930; and Henny, 1931).

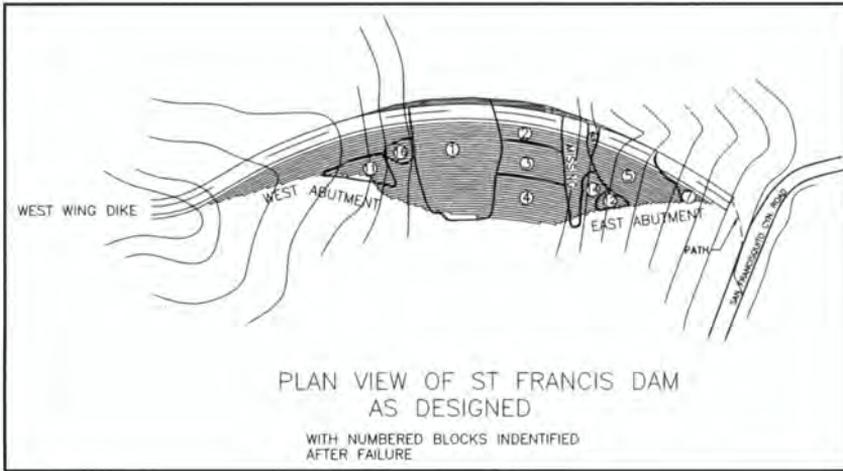
Figure 4 (upper) - Plan view of the main section of St. Francis Dam as originally designed from DWP files. Diagonal lines and numbers delineate the dam blocks identified in the post-failure analysis by the Governor's Board of Inquiry (shown in Figure 9). The dam's horizontal steps were each five feet high and varied in plan, from 5.5 feet in the lower part of the structure to as little as 1.5 feet in the uppermost part of the dam. The unique spacing of the steps allowed for a good deal of forensic puzzle-solving in the post-failure analysis.

provision had been made for emplacement of expansion joints within the main structure. The main portion of the dam was arched upstream, on a 500-foot radius, as depicted in plan in Figure 4. Additional load-carrying capacity due to arch action was neglected in the dam's design, a common and seemingly conservative decision. During the Los Angeles County Coroner's Inquest following the dam's failure, Mulholland would testify that the dam was designed with a "factor of safety of three or four" (Mulholland, 1928, p. 10).

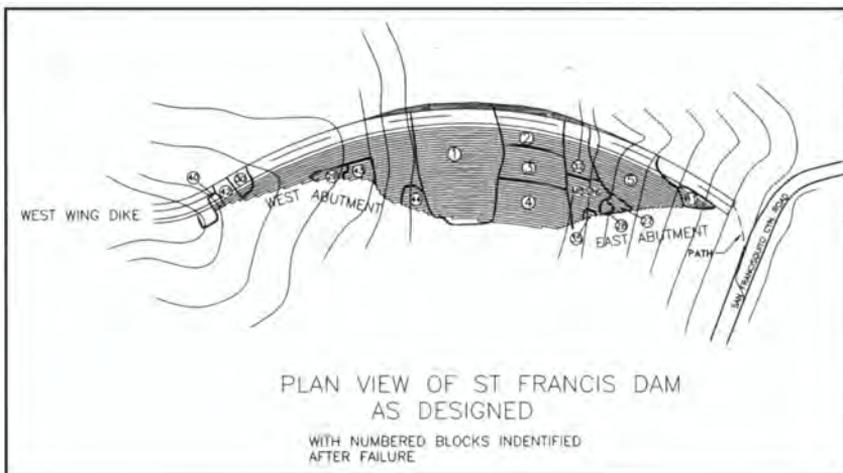
Figure 4 (lower) - Same plan view as above, but with the displaced block designations assigned by the Bureau of Water Works (taken from Lee, 1928b). These blocks were identified through a more extensive program of analysis than those of the Governor's Board.

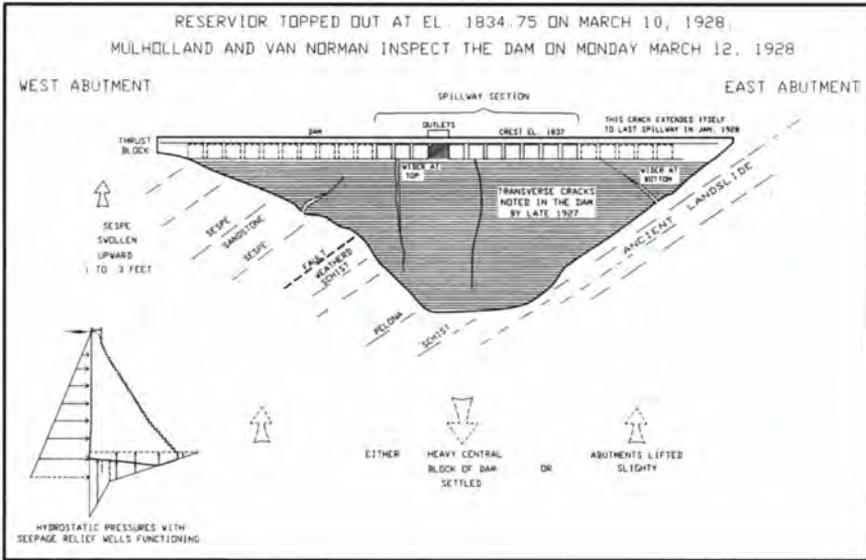
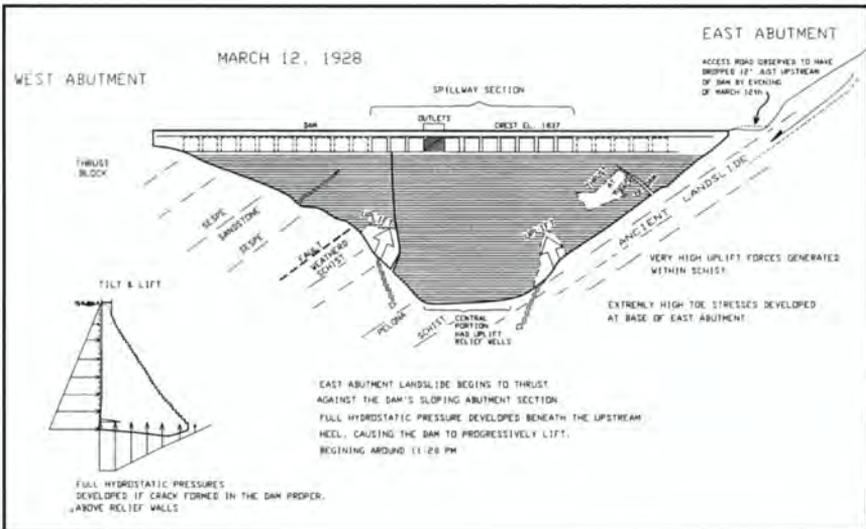
Figure 5 - Schematic elevation view of transverse cracks which appeared on the downstream face of the dam prior to its failure. The four cracks most often described are portrayed, their having been formed by late 1927. Both abutment cracks were angled obliquely, and widest at their junctures with the foundation rock, suggesting abutment uplift. The two longest cracks, in the dam's central section, were later found to be those bordering Block 1.

structure was comprised of 130,500 cubic yards of concrete, placed in just sixteen months). Two sets of cracks appear to have formed, those on the steeply rising flanks of the structure, and two within the maximum section. The approximate locations of these fractures, deduced from verbal descriptions and photographs, are depicted schematically in Figure 5. The flank cracks were observed to be wider at their juncture with the abutments, narrowing upwards; while the two longer, main section cracks appeared widest at the top, near the parapet wall. The transverse cracks within the main dam block were infilled with hemp and sealed with wedges of oakum on the downstream face. These were then back-filled with cement grout to seal off active seepage.

The apparent conditions at the dam site on Monday evening, March 12, 1928, are depicted schematically in Figure 5. No less than four separate parties drove by the dam within an hour of its apparent failure just before midnight. All of these people were Bureau of Power and Light employees stationed at Powerhouse No.1, five miles up-canyon above the dam.

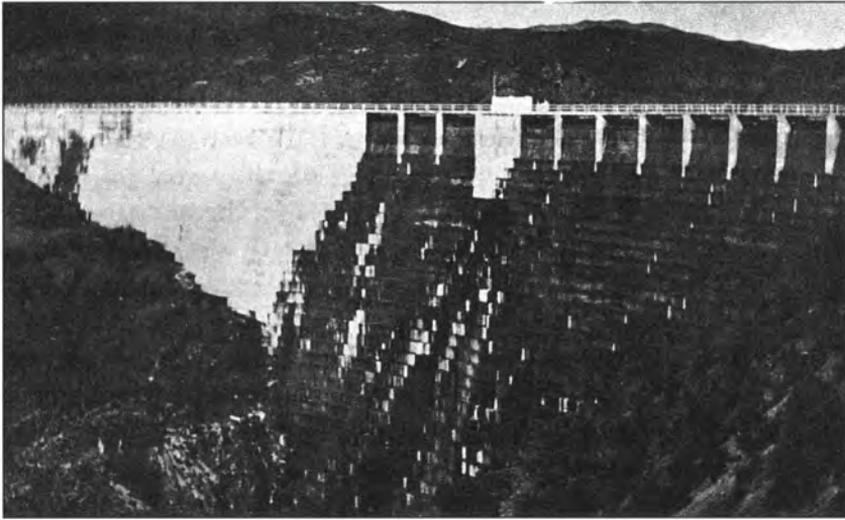
Figure 6 - View of downstream face of St. Francis Dam, taken around noon on Monday, March 12, 1928, the day of the failure. Note the windswept spillage coming over the spillways, thereby complicating the task of discerning last minute leakage from spillage. At this time approximately 2 cfs of water was running down the west abutment contact, shown at left center. Photo from the Los Angeles Department of Water and Power.

When the spring runoff began arriving in January 1928, the reservoir was allowed to fill to maximum capacity, reaching elevation 1,834.75 (three inches below the spillway slits) on March 7, 1928, whereupon no additional aqueduct water was diverted into the lake. The previous year's leaks suddenly gushed forth with additional discharge and new leaks developed on both abutments. During the first week of March, a very noticeable leak developed along the wing dike that was issuing artesian flow of about 0.60 cubic feet per second (cfs). Mulholland ordered a work crew to install an 8-inch-diameter concrete pipe underdrain from this point, eastward along the base of the dike, to discharge along the west abutment contact of the main dam section, giving an appearance that there was seepage emanating along this juncture (Figure 6).

Wave-whipped water was issuing over the dam's spillway slits, even though the lake had dropped to 1,834.3 over the previous forty-eight hours (Figure 6). Their inspection revealed that about 2 cfs outflow was then issuing from the Sespe beds on the right (west) abutment, but the water was decidedly clear where it was

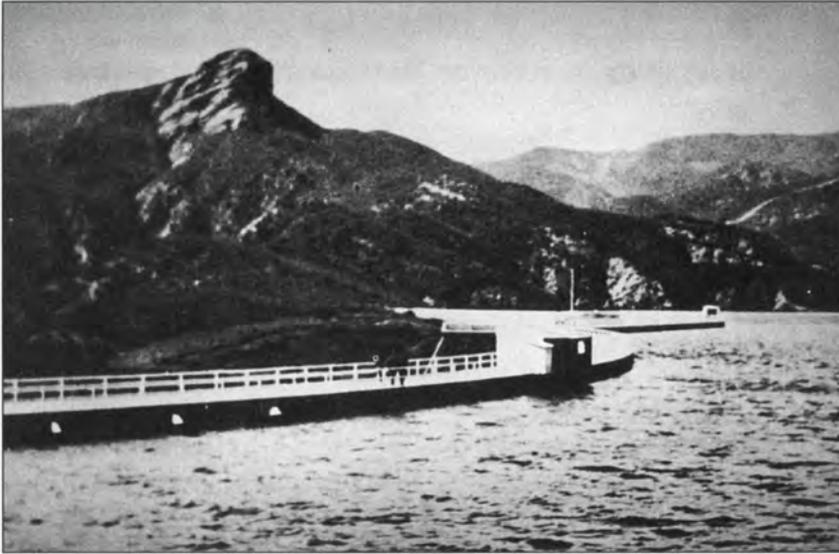
Figure 7 (upper) - Bill Mulholland, Harvey Van Norman and damkeeper Tony Harnischfeger walking across the crest of the swollen dam around noon on March 12, 1928, approximately 12 hours before the failure. The west dike, running across the top of a natural ridge in the Sespe formation red beds, lies at right center. Photo from the Los Angeles Department of Water and Power.

That same morning, the BWWS damkeeper, Tony Harnischfeger, had telephoned Mulholland to say that a new, larger leak had developed on the Sespe abutment, and that the discharge was "dirty," cause for concern to any dam engineer, as this would be an alarm to the possibility of hydraulic piping. It was a Monday morning and Mulholland, very much the personification of "the man in charge," chose to personally inspect the dam immediately with Harvey Van Norman, Mulholland's Assistant Chief Engineer (according to his subsequent testimony at the Coronor's Inquest, Mulholland made a practice of visiting all of his nineteen dams once every ten to fourteen days).²⁸ Mulholland and Van Norman arrived by chauffeured BWWS car at the dam at 10:30 a.m., whereupon they inspected the dam for the next two hours (Figures 6 and 7 upper).

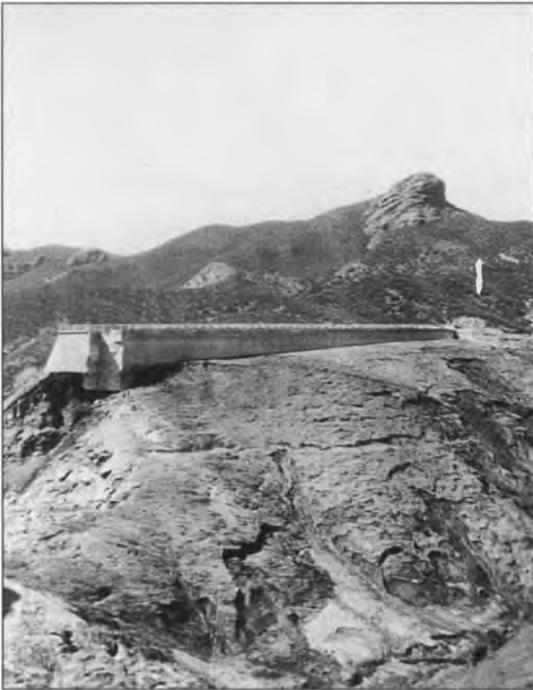
Figure 7 (lower) - Approximately the same view, as seen the following day, after the dam failed, leaving the west dike in place. Water had been leaking from beneath this dike the previous day. Note the widespread occurrence of shallow earthflows on the Sespe slope, likely due to rapid drawdown-induced pore pressure differential as the reservoir emptied in less than an hour. Photo by permission of Ventura County Museum of History & Art.

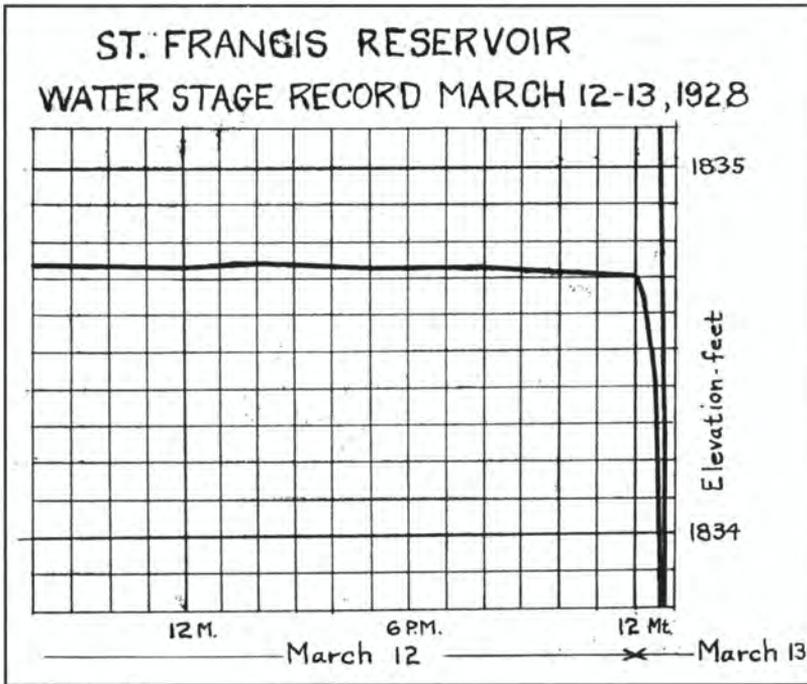
Figure 8 - Ink overlay of the pencil trace of the Stevens Automatic Water Stage Recorder recovered from the lone remaining piece of the dam, Block 1 (taken from Lee, 1928b). Although not designed for minute to minute precision (the trace was only changed once per week), a literal translation of the record suggest that the reservoir dropped 3.6 inches in an accelerating manner, beginning around 11:20 p.m., or about 40 minutes preceding the failure (though no discharge was observed). An alternative explanation would be that the dam was beginning to tilt downstream, and would have begun to develop excessive tensile force at the upstream toe (see Figure 24).

What happened next has been subject to considerable speculation since the time of the failure. The record of a Stevens Water Stage Gage, situated upon the deep, central core of the dam, was retrieved after the failure (as it was situated on the lone remaining piece of the dam).³⁸ A tracing of this gage prepared by Lee (1928) is presented in Figure 8. An examination of the pencil trace on the recording graph paper indicated that in the forty or so minutes prior to the dam's catastrophic failure, the lake level appeared to have lowered about 3.6 inches in an accelerating manner. The dam was presumed to have failed at 11:57:30 p.m., as that was the time the Southern California Edison (SCE) Lancaster (Borel) power line, running along the east abutment, was suddenly cut. This power line extended the length of San Francisquito Canyon on a series of tandem poles with cross bars and was located about 90 feet above the east abutment crest of the dam (depicted in Figures 16, 19, and 29), suggesting that it was too high above the canyon bottom to have simply been severed by water gushing forth from the broken dam.³⁹

The Stevens Gage consisted of a 12-inch diameter pipe affixed to the upstream face of the dam (seen in Figures 19, 26 lower, and 29). Water fed into this “stilling well” through a 1-inch diameter hole at its lower extremity. The intent of a stilling well was to filter out the oscillatory effects of wind-whipped waves on the back of the dam. In the failure’s aftermath, many engineers attempted to correlate the apparent drop of .035 feet in lake level recorded by the gage between 8 and 11:30 p.m.. This drop, if it actually occurred, would have corresponded with an outflow of 934,580 cubic feet of water. Numerous attempts were made to estimate the outflow volume

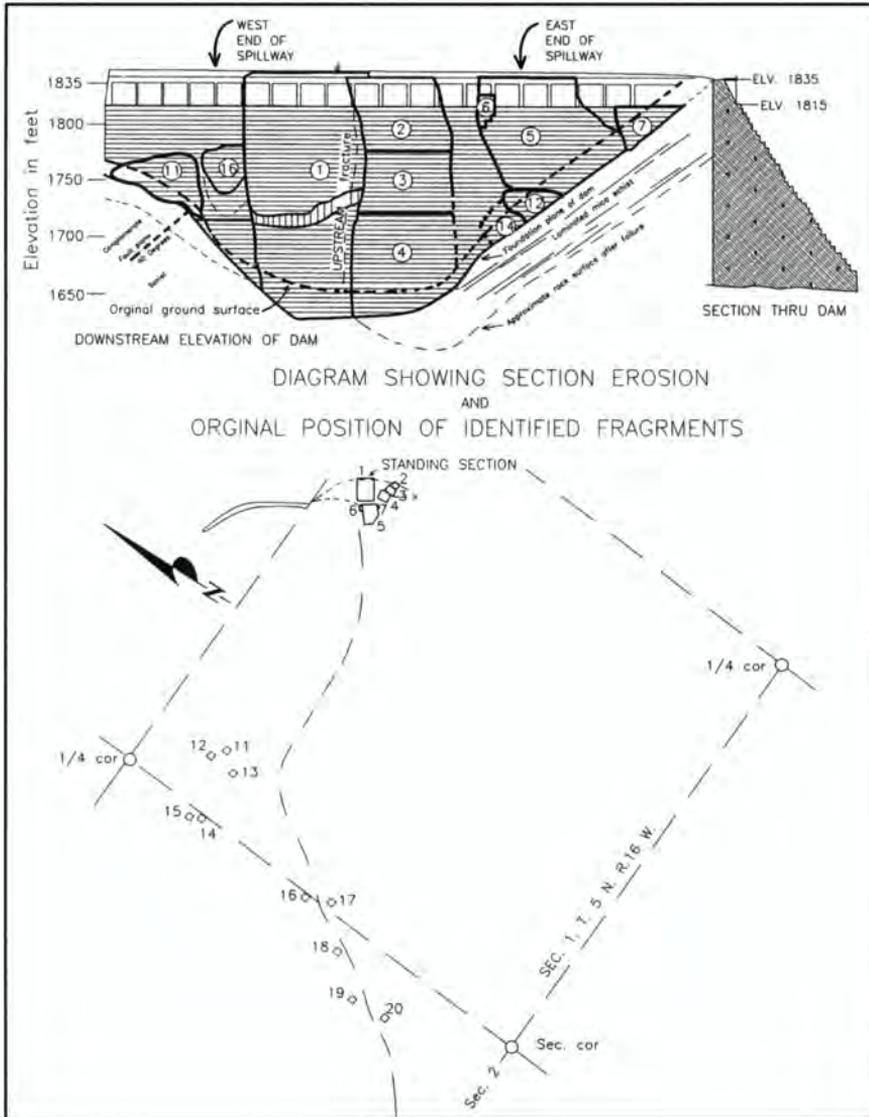
Figure 9 - Distribution of fragments from the St. Francis Dam, as delineated in the report by the Governor's Board of Inquiry, issued 11 days after the failure. Some of the largest and most easily identified fragments were observed to have emanated from the dam's west (right) abutment, but smaller blocks from the east (left) abutment had not been identified at the time of the failure.

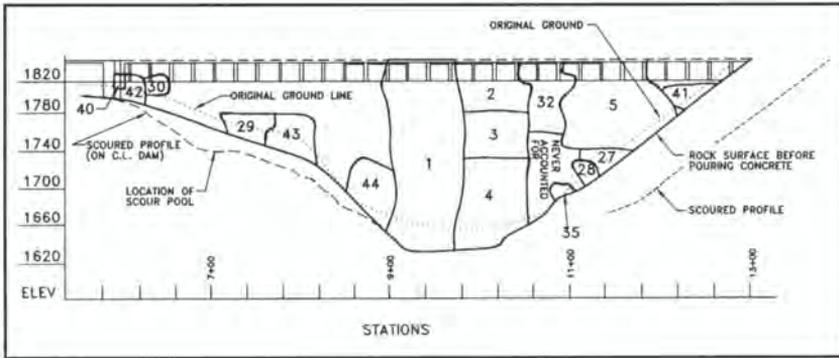
Figure 10 - Distribution of fragments from St. Francis Dam as identified in an aerial photograph of the canyon by Bureau of Water Works engineers in the weeks following the failure. Detailed examination revealed that it was blocks from the base of the so-called "missing section" on the east abutment that were found furthest downstream, not those from the opposing abutment, as reported by the Governor's Board (shown previously). Taken from Lee, 1928b.

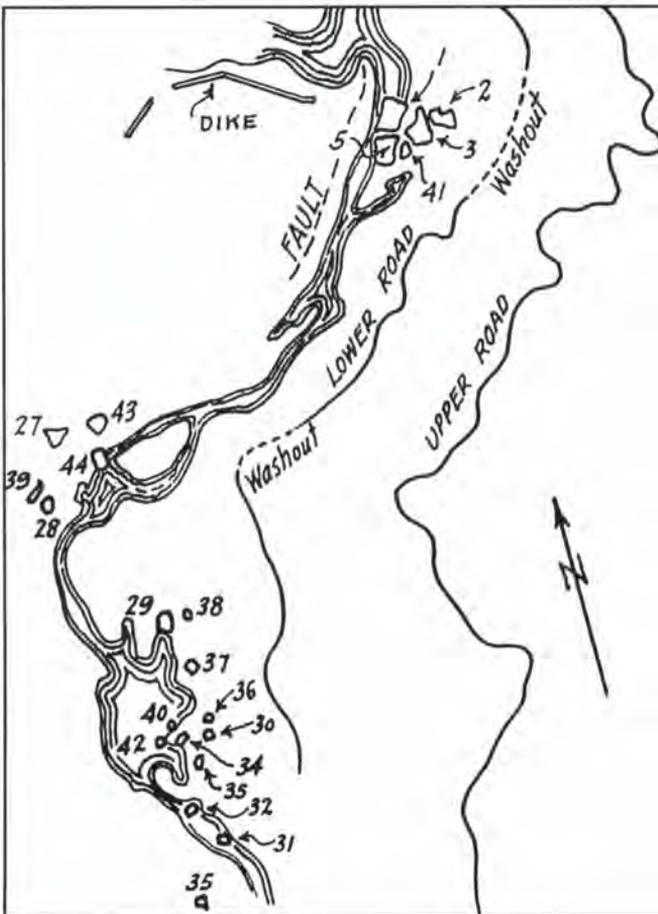
Figure 11 [at right] - Vertical aerial photograph of the St. Francis Dam and downstream area taken about a week after the failure by Fairchild aerial surveys. It was upon this photo that BWWS engineers and surveyors identified and delineated the locations of displaced blocks shown in the figure at left. Note the location of Block 35, found furthest downstream.

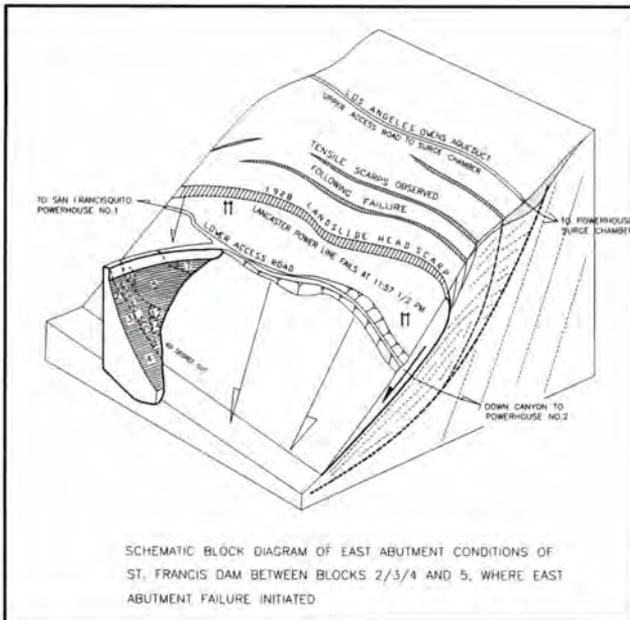
Figure 13 - Schematic block diagram of the conditions on the east abutment of St. Francis Dam just prior to its failure in March 1928. Most of the so-called “missing section” of the east abutment was subsequently identified as Blocks [27], [28], [32] and [35], found the furthest downstream. It can be appreciated that these blocks lay above keyblocks A, B and C shown in the previous figure, which coincided with the steepest excavation made for the dam. The approximate area limits of the east abutment slide are shown, as well as that of Edison’s Borel 60 Kv power lines that went down at 11:57:30 p.m. on the evening of the disaster. These lines were situated 90 feet above the dam crest.

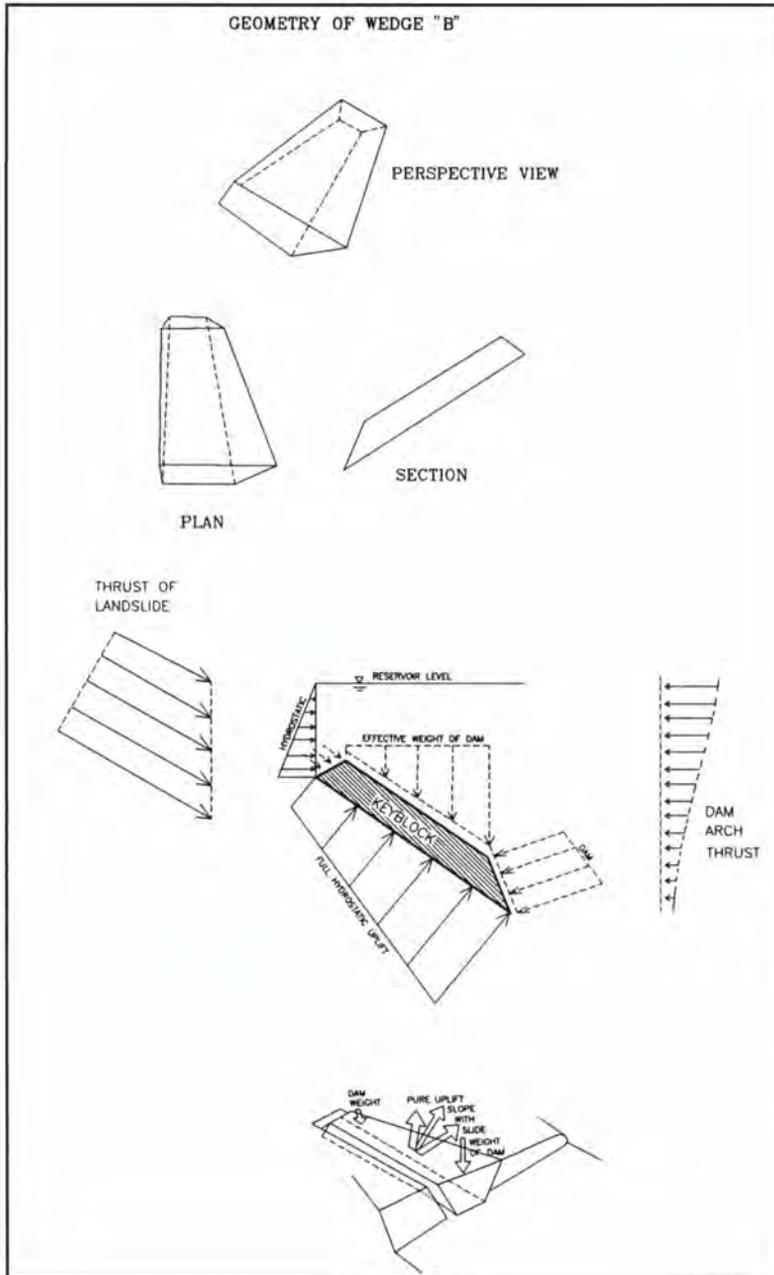
Figure 14 - Plan, section and perspective views of keyblock "B", shown schematically in Figure 13. The section view parallels the schist foliation, the lower face that of the abutment excavation. The lower view shows an approximation of the loads that were likely acting on this and adjacent wedges beneath the east abutment after the maximum reservoir pool was attained five days preceding the failure. A simple stability analysis suggests that two-thirds of the lake's full reservoir head would have been sufficient to have lifted this block, with the dam upon it, the same manner of failure by which Malpasset concrete arch dam later failed in 1959.

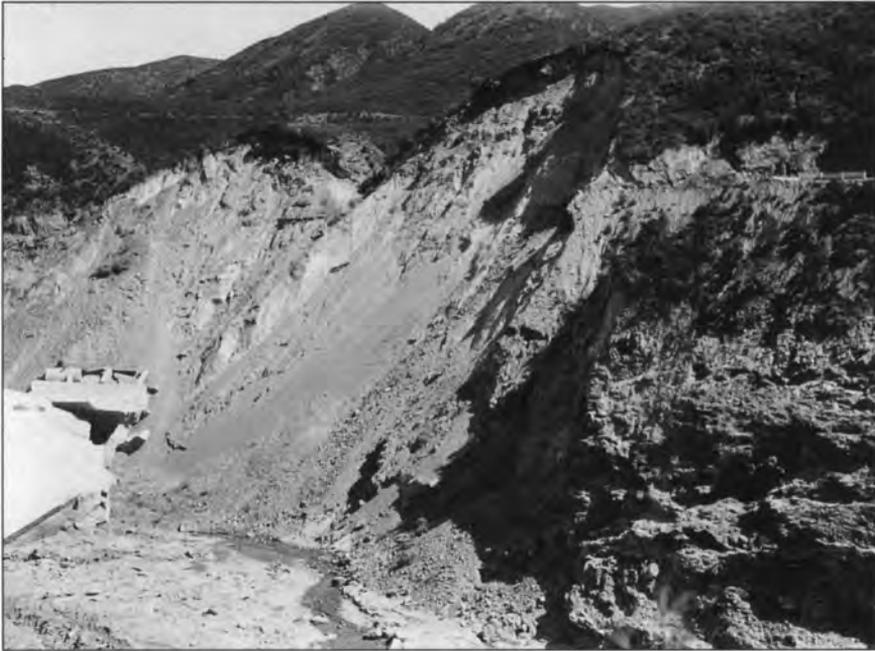
Figure 15 (upper) - View looking southeast, at east abutment slide scar, from position of Edison power poles, across canyon, after the failure. The enormity of the slide can be vividly appreciated, with a mass of well over 500,000 cubic yards.

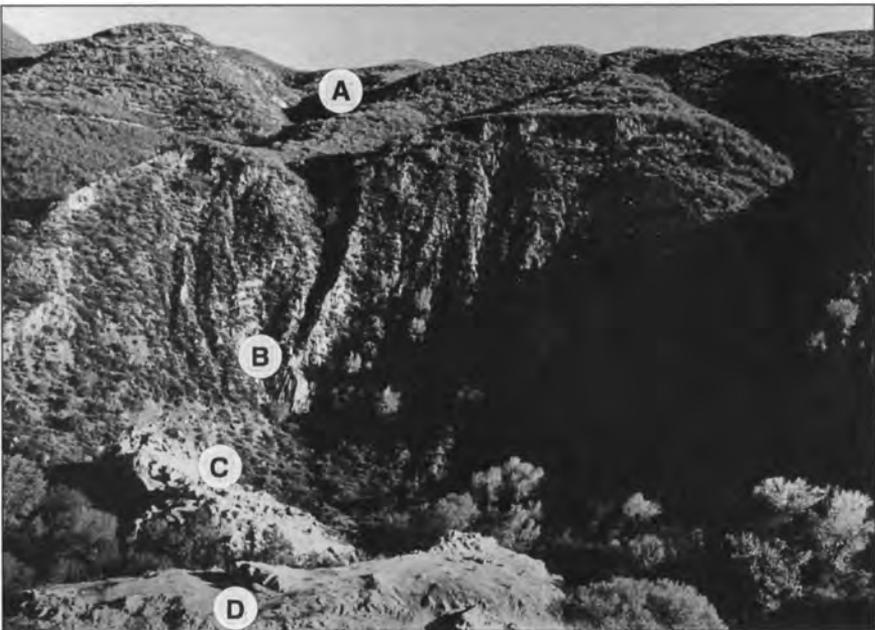
Figure 15 (lower) - The same view as seen at the damsite in 1989. "A" indicates the position of the highline road to the Powerhouse No. 2 surge chamber (still operative); "B" is the outcrop of schist utilized in making the keyblock analysis; "C" are the remains of dam Blocks 2 and 3; and "D" is the remains of Block 1, demolished in mid 1929.

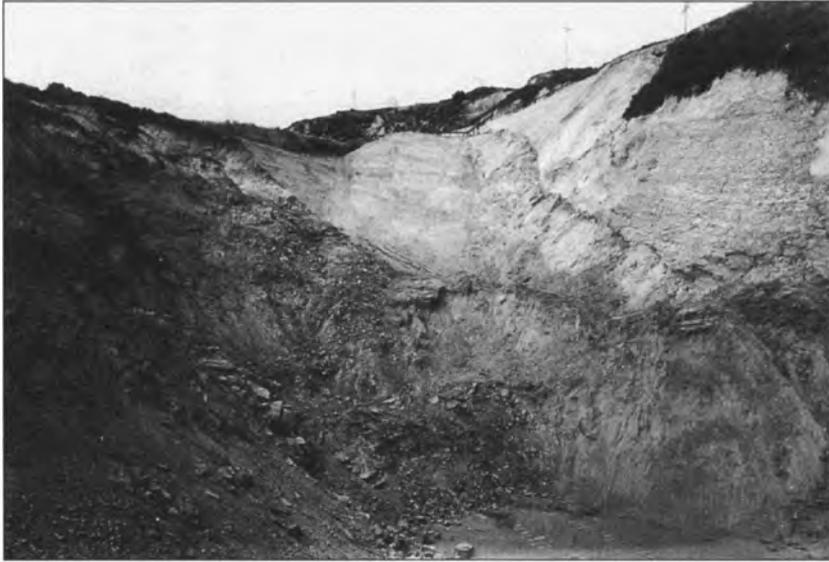
Figure 16 (upper) - View looking uphill into the evacuation scar of the 1928 east abutment slide, as seen from the floor of the canyon, just downstream of the dam's former position. This photo shows the guardrail of San Francisquito Canyon road parallel to the slide's west headscarp, thereby fixing its relative vertical position (as shown on Figure 17). Photo by permission of Ventura County Museum of History & Art.

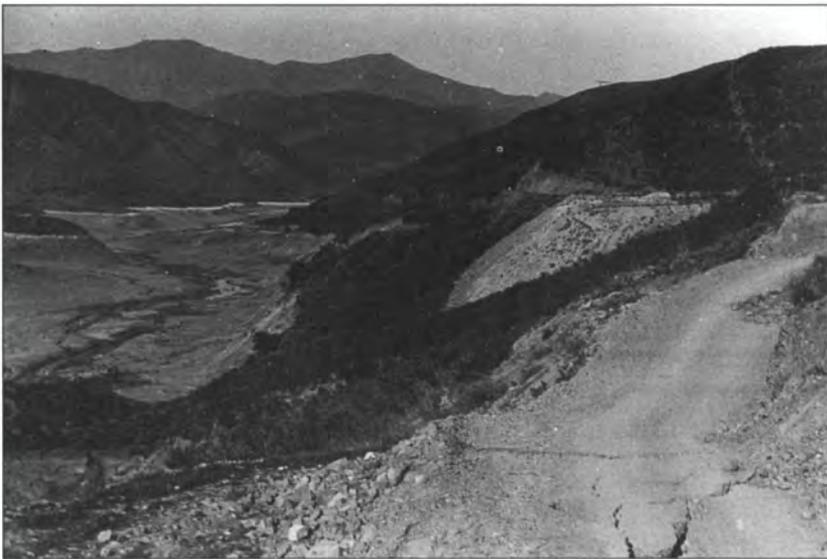
Figure 16 (lower) - View looking up-canyon from the highline, or surge chamber road, immediately above the east abutment slide headscarp (position "A" in lower portion Figure 15), a few days after the failure. Retrogressive tension scarps reached 200 feet uphill of the slide, dropping this upper road by about 10 feet. Note the tandem poles of the Edison Borel power line, well above the level of the reservoir. In this area the highline road approximates the headscarp of the ancient landslide complex shown in the lower half of Figure 1.

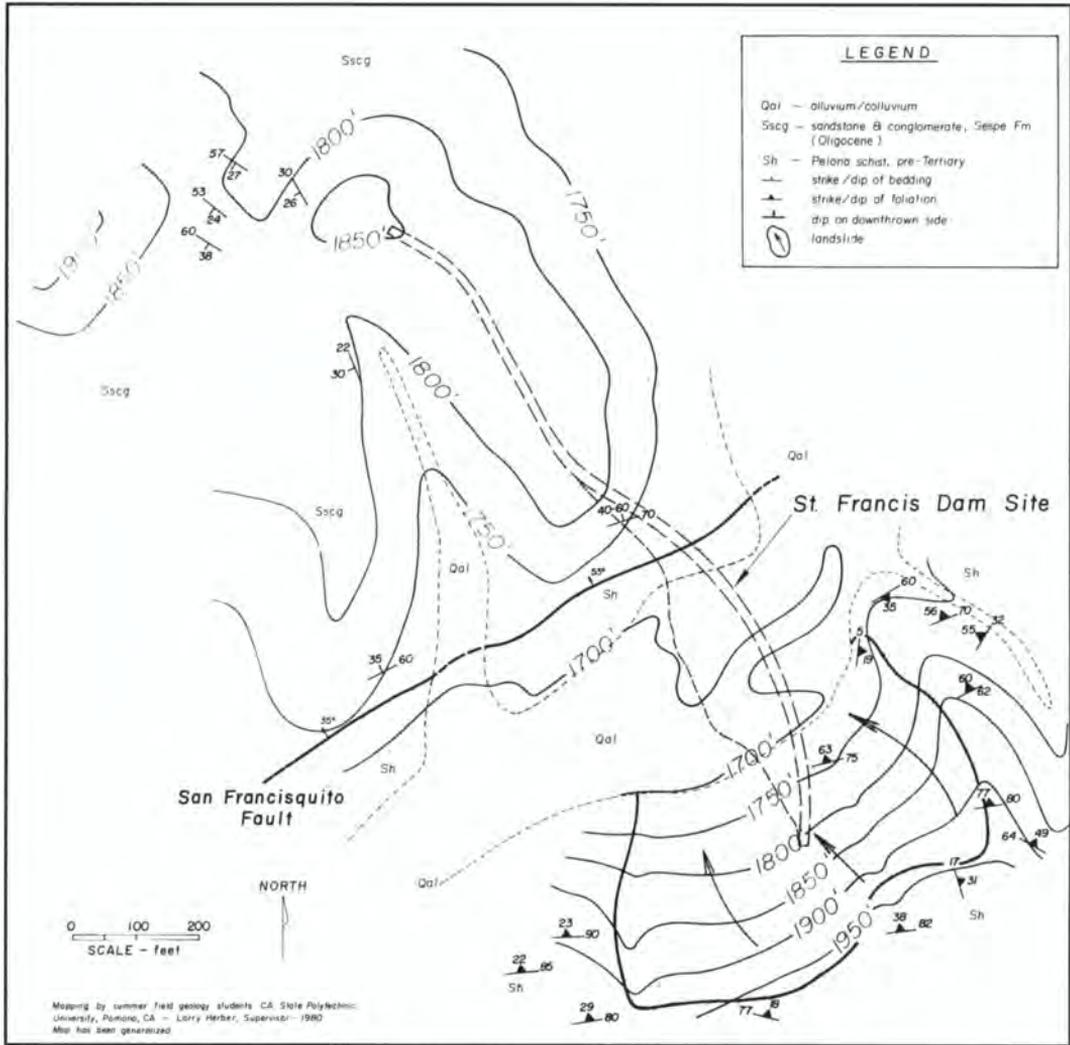
Figure 17 - Surface geologic and topographic map of the St. Francis Dam site as it appears today, prepared under the direction of Professor Larry Herber at Cal Poly Pomona in 1980. The positions of the San Francisquito fault and the east abutment slide relative to the main section of the dam are easily discerned. Foliation attitudes in the Pelona Schist are reversed in the extreme toe areas of the paleomegaslides.

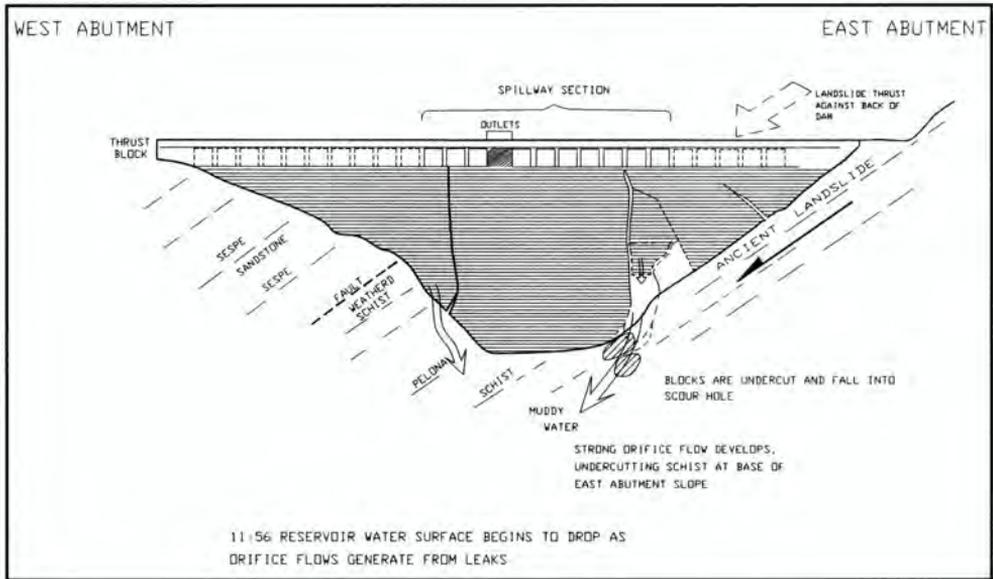
Figure 18 (upper) - Schematic elevation view of onset of undercutting in vicinity of Blocks [35] and [28], at the toe of the east abutment slide, between Blocks 2/3/4 and 5/6/7. This sequence likely initiated between 11:50 and 11:55 p.m., and would have been hidden from the view of people driving along the road passing above the east abutment crest.

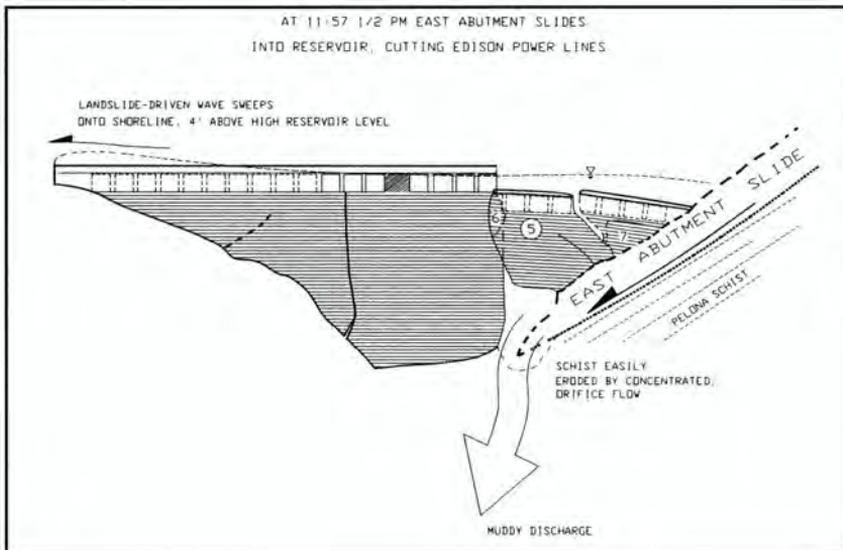
Figure 18 (lower) - Schematic portrayal of the initial mobilization of the east abutment slide, around 11:57:30 p.m. A rather sudden mass movement is suggested by several facts, including, but not limited to, the dropping of the Edison power lines some 90 feet above the dam crest at this instant (arguing against a toe-headward, progressive style of failure); the creation of wave flotsam 4 feet above the maximum reservoir level; and the apparent movement of Blocks 5/6/7 completely across the downstream face of the dam, with Block 7[41] being found upstream and behind Block 5.

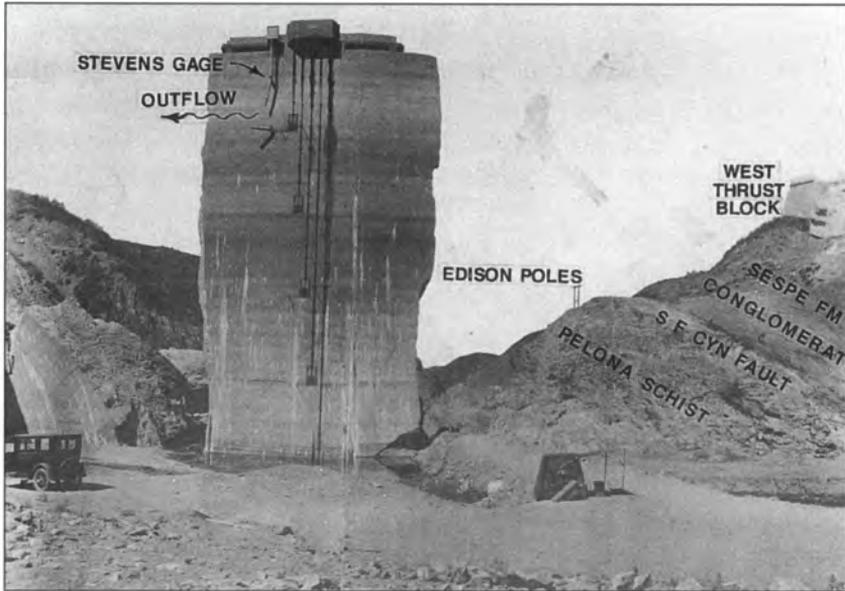
Figure 19 - Post-failure view looking downstream, at the upstream face of the lone remaining section of the main dam. The thin black lines running vertically down the back of the dam are the gate controls for the dam's five outlet conduits. The snapped portion of the 12-inch diameter housing for the Stevens Water Stage Gage is clearly seen to the left of the uppermost outlet gate, pointing towards the east abutment, between elevation 1,800 and 1,815. The lake had been at elevation 1,834.4 just prior to the failure. Photo by permission of Ventura County Museum of History & Art.

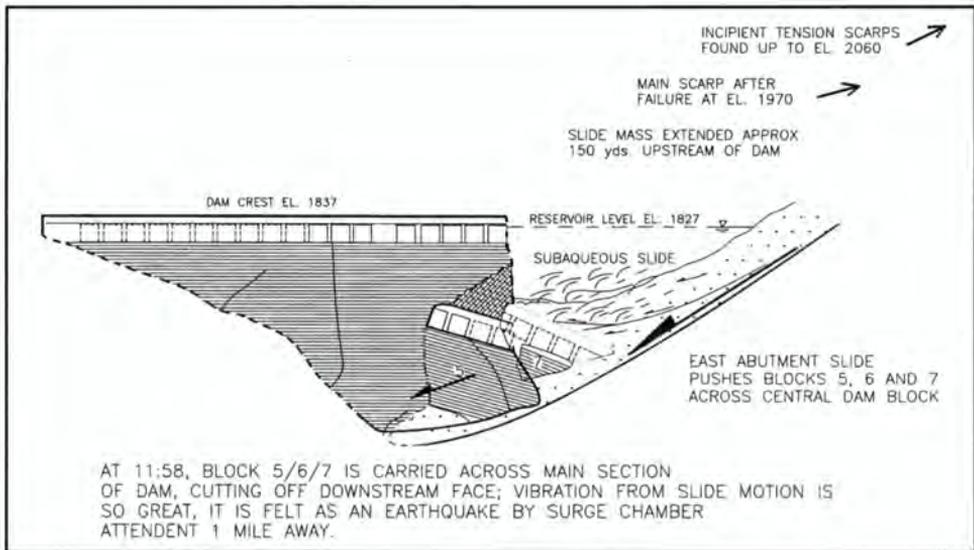
Figure 20 (upper) - Schematic portrayal of the east abutment slide carrying Blocks 5/6/7 across the downstream face of the dam's central section (Blocks 1/2/3/4) early on in the failure sequence. At this time the lake appears to have been near its maximum pool level, above elevation 1,827. The outer 20 feet of the dam's face was abraded by the movement of Blocks 5/6/7.

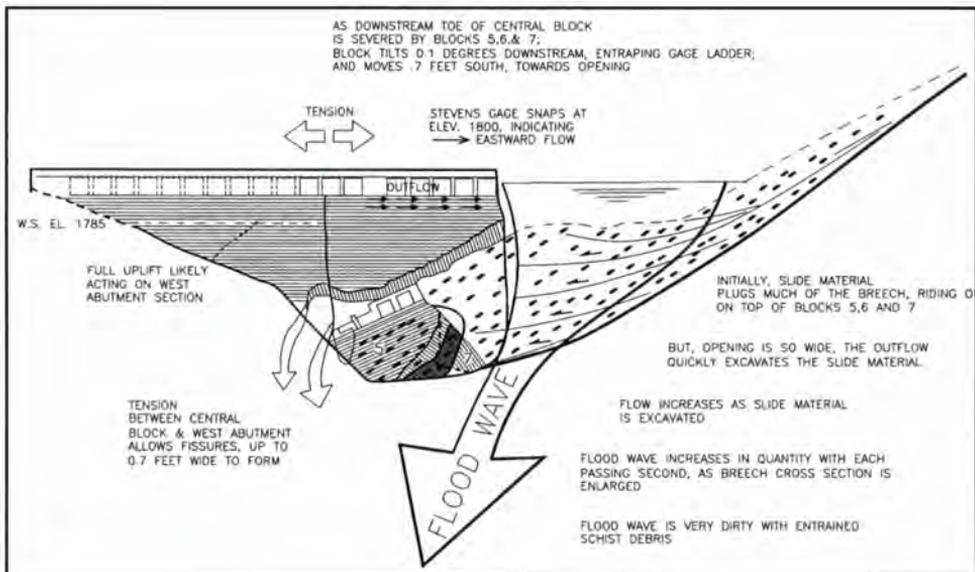
Figure 20 (lower) - Schematic portrayal of the landslide dam, temporarily formed across the east abutment breach. Slide debris likely overthrust upon itself, building up a short-lived impedence to outflow. This temporary dam allows for the 60 to 90 seconds of flood water build-up related by survivors at Powerhouse No. 2 before the maximum discharge peaked and then began to reced. The Powerhouse No. 2 community was destroyed at 12:02-1/2 a.m., 5 minutes after the Edison power lines went down.

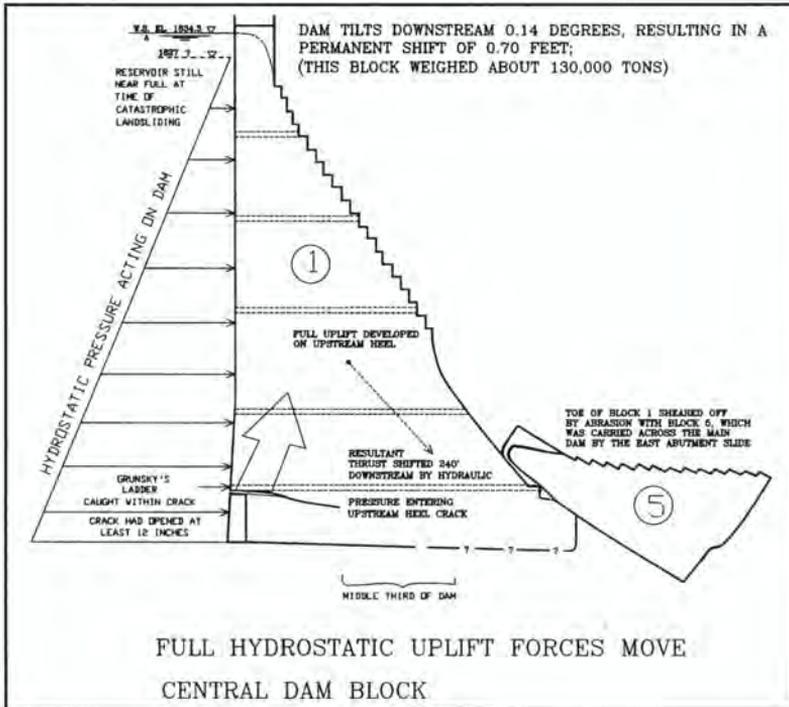
Figure 21 - Loading conditions likely exerted upon Block 1, based on physical evidence observed immediately following the failure. The snapping of the Stevens Gage around elevation 1,815 suggest that the reservoir was still nearly full when the east breach was developing maximum outflow conditions. If reservoir water entered the heel crack in vicinity of Grunsky's ladder, the dam's resultant thrust would have been shifted 240 feet downstream of the structure (the resultant thrust must remain in the middle third of the dam's base for the structure to be stable). The crushed ladder (Figure 24) is mute testimony that this crack must have opened as much as 12 inches, more than enough to have created the tilting displacement recorded by the Steven's Gage (Figure 8).

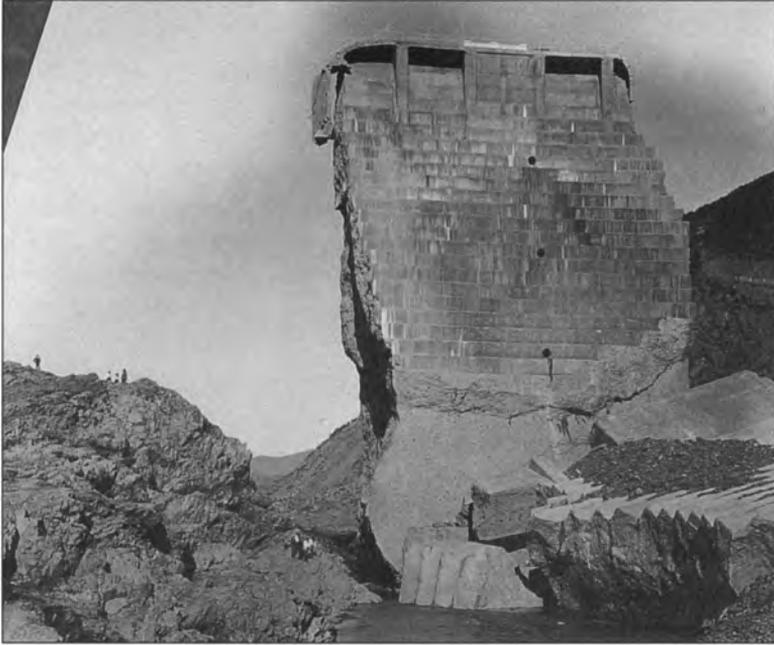
Figure 22 (upper) - Ground view looking upstream at the mass of Block 1 with Blocks 5/6 in right foreground. Note level of schist detritus atop Block 5, well above the channel bed, which is still flowing when this photo was taken four days after the failure. Huber Collection, University of California Water Resources Center Archives.

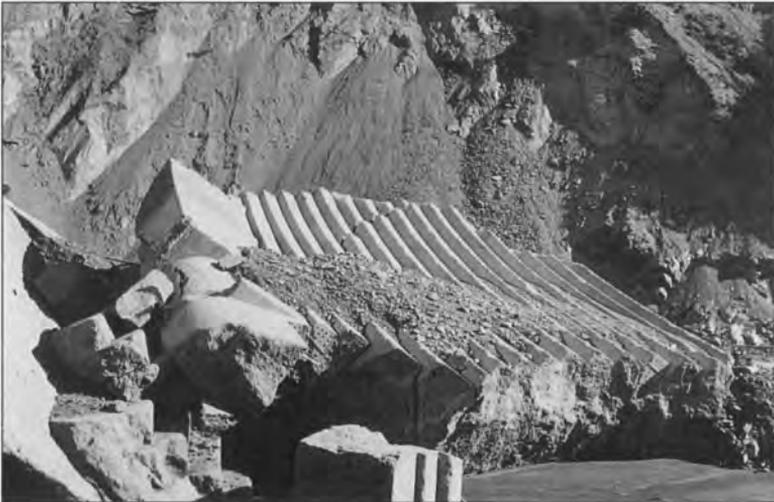
Figure 22 (lower) - Close-up of Blocks 5 and 6, as seen after the failure. The two lowermost steps of Block 1 remained intact. Note the accumulation of schist detritus upon Block 5, about 25 to 30 feet above the creek bed.
