A Man, A Dam and A Disaster: Mulholland and the St. Francis Dam

by *J. David Rogers*

St. Francis Dam Disaster Revisited

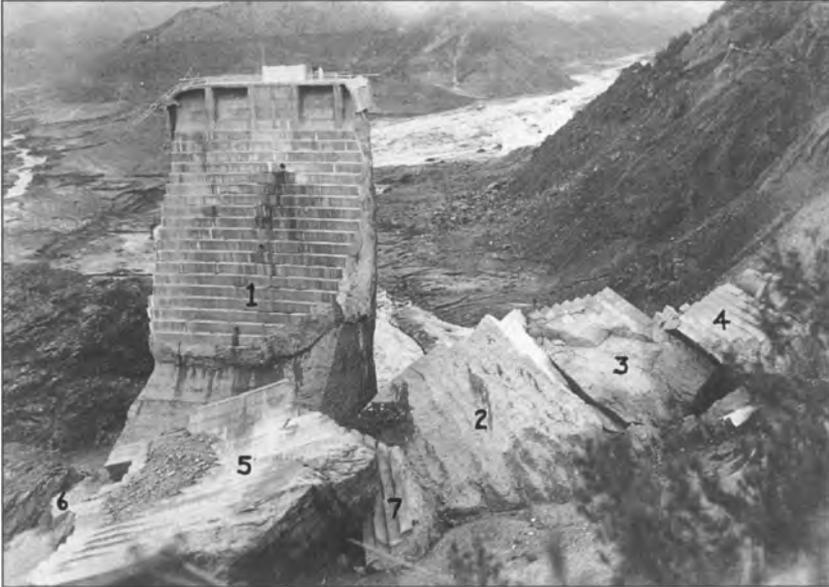
Figure 23 - Photo looking upstream showing the final resting positions of the east abutment and main section blocks. Note the schist detritus left upon Blocks 4 and 5, as well as the position of Block 7[41], behind Block 5. The oakum patch of the crack in Block 5 is also very apparent. Blocks 2/3/4 separated very late in the failure sequence, when much less water was available to dislodge them (they toppled upstream). Photo from University of California Water Resources Center Archives.

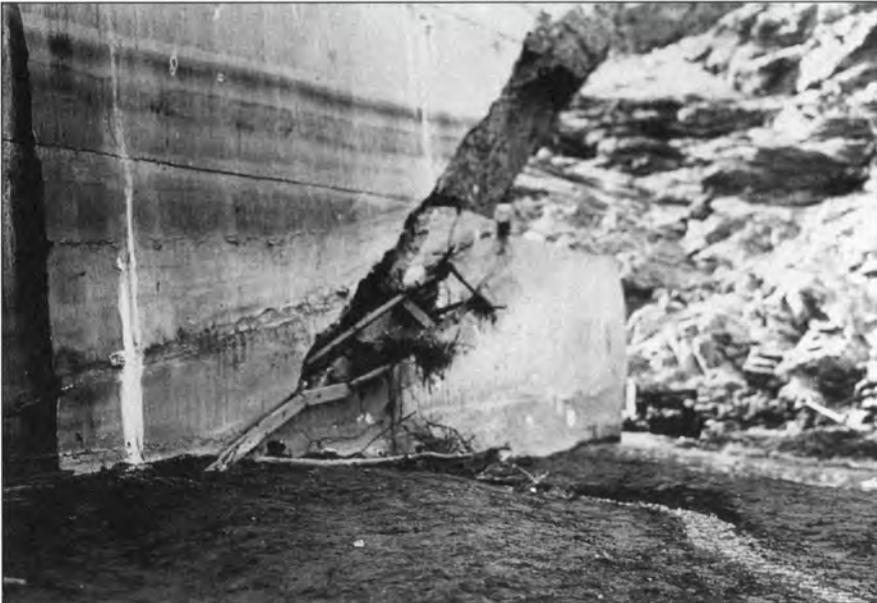
Figure 24 - Photo showing the upstream gage attendant's ladder wedged into a major crack at the west upstream heel of Block 1. This was often referred to as "Grunsky's ladder," because engineer C.E. Grunsky made its discovery after the reservoir's water had receded (the ladder was underwater for several days after the failure). Block 1 would have to have tilted at least 12 inches to swallow up the ladder, which was 18 inches wide. There is little doubt, therefore, that the upstream heel of the dam's central section was in tension and that, at some point, either before or during the failure sequence, full hydrostatic pressures must have acted upon the block's interior, significantly negating its effective dead load. Photo from Huber Collection, University of California Water Resources Center Archives.

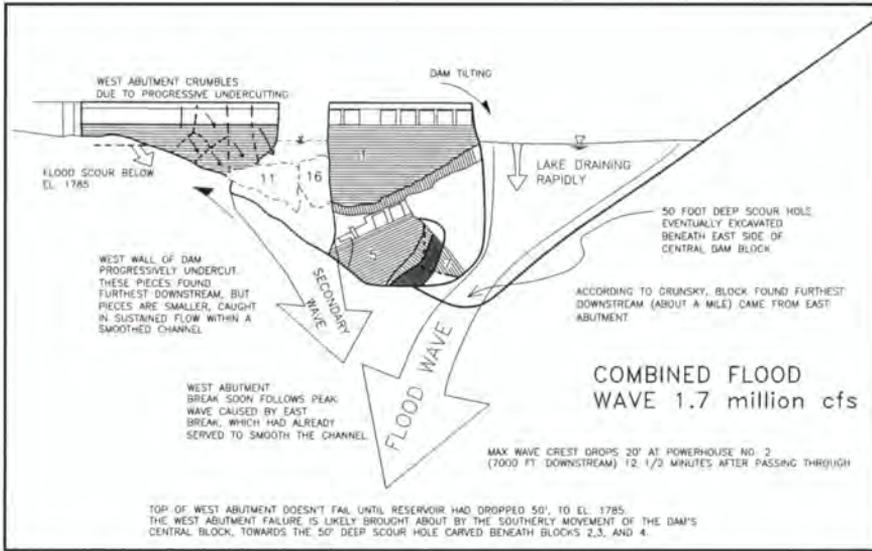
Figure 25 (upper) - Schematic portrayal of east and west breaches combining to form the maximum discharge of 1.7 million cfs, sometime around midnight on March 12/13, 1928. This wave crested at Powerhouse No. 2, 3,700 feet downstream, sometime between 12:02:30 and 12:08; receding 20 feet by 12:15 a.m. The maximum outflow was likely caused by the rapid erosion of the debris plug created by the east abutment slide at 11:57:30 p.m.

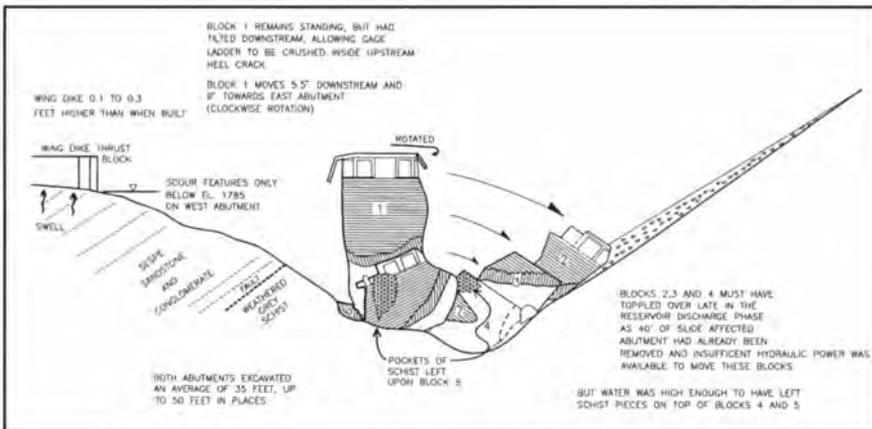
Figure 25 (lower) - Schematic portrayal of the final stages of the St. Francis failure. The west abutment was scoured away very quickly once the initial piercement occurred, just west of Block 1. Blocks 2/3/4 were undercut by the outpouring through the massive landslide breach, eventually toppling backward, into a hole 50 feet deep. This is how the scene appeared the next morning (Figure 23).

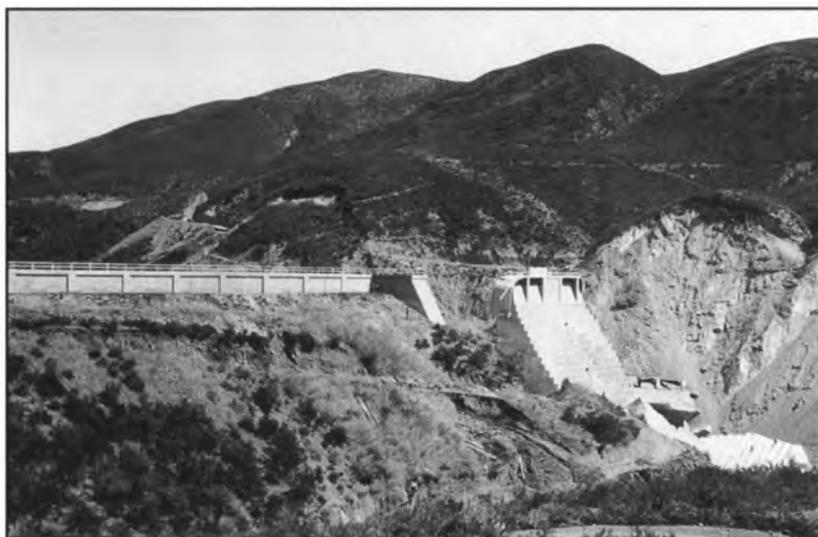
Figure 26 (upper) - View looking across side canyon just below right abutment, near position of Figure 1, just after the failure. Note how the vegetation scour line cannot even be seen, suggesting that the right abutment failed only after the reservoir had dropped at least 60 feet from the crest. Photo from the Huber Collection, University of California Water Resources Center Archives.

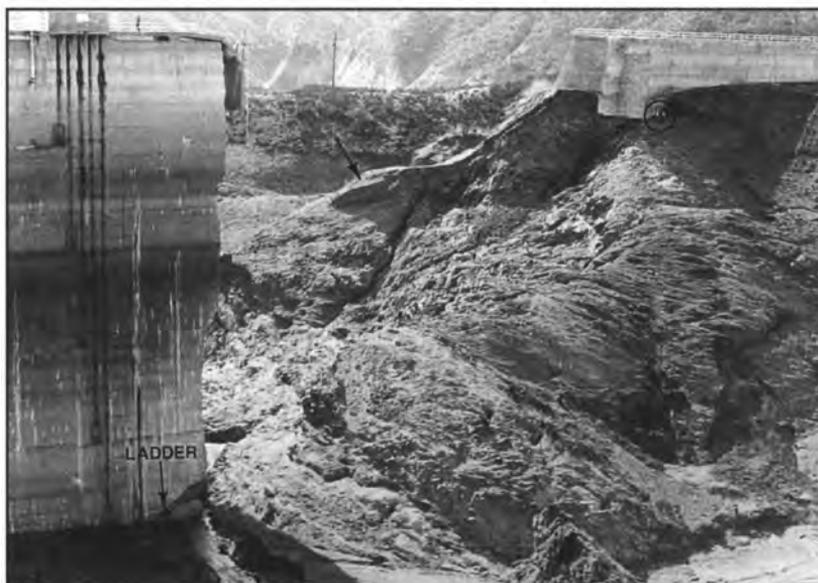
Figure 26 (lower) - Detail of failed west abutment, looking downstream, with people circled for scale. Only a portion of the sidecast fill for the construction road was excavated by the outpouring water (arrow), with scrub brush left upon the cut slope side down to elevation 1,775, 60 feet below the reservoir level. Photo by permission of Ventura County Museum of History & Art.

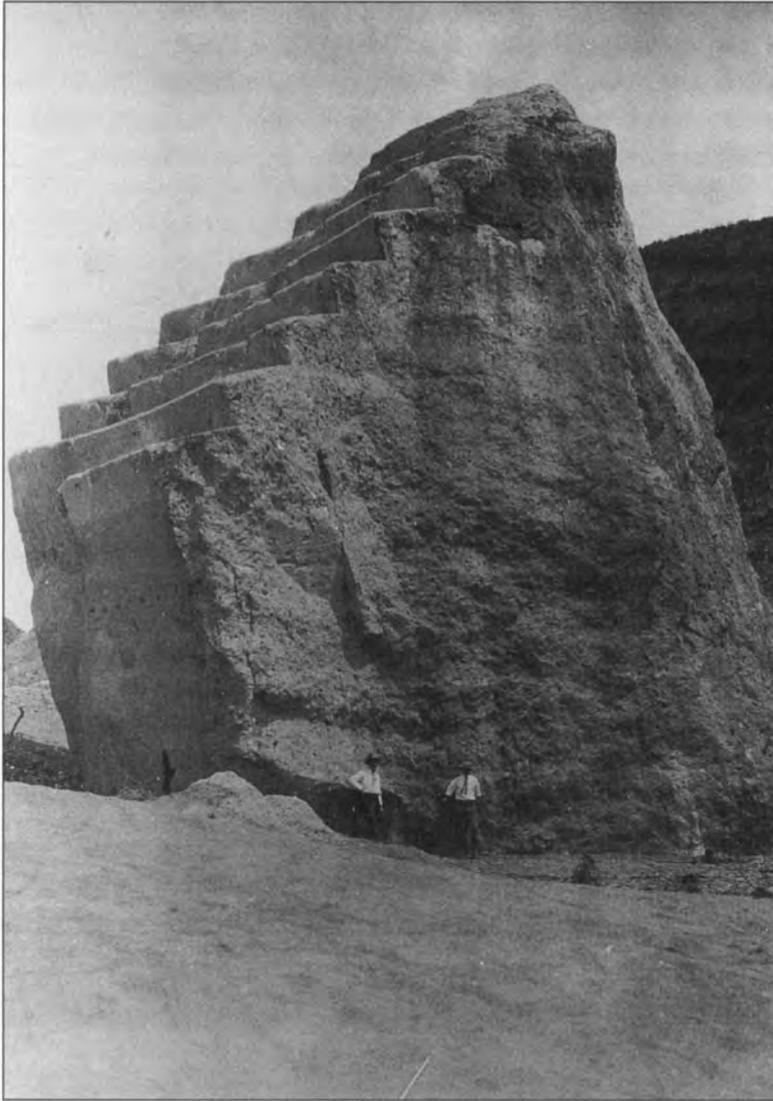
Figure 27 - Close-up view of dam Block 16 [29], which at 10,000 tons was the largest piece of the dam moved any appreciable distance downstream (as shown in Figures 9 and 10). This block came from the lower part of the west abutment, adjacent to Block 1, which remained standing. The small holes visible on the upper cold joint were for the form rakers used to hold the forms for the downstream steps when the concrete was poured. Blocks of such immense size can be transported in a dirty fluid or slurry, which greatly diminishes their effective weight, as shown in Figure 30 upper. Photo by permission of Ventura County Museum of History & Art.

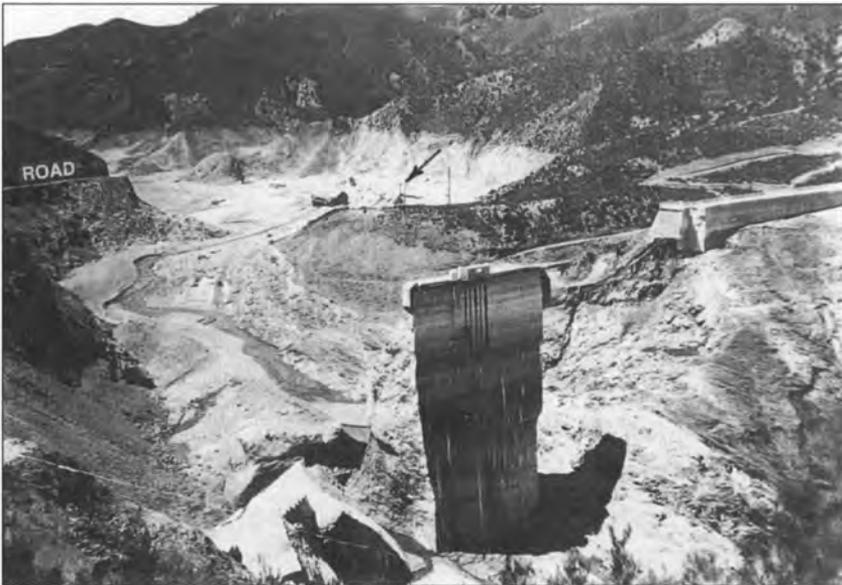
Figure 28 - Overview of the flood's aftermath, immediately downstream of the dam. The flood wave scoured the canyon's slopes to a maximum depth of 120 feet above the stream level. Edison's Bore line crossed the channel, but was situated above the maximum scour line (arrow). San Francisquito Canyon road began climbing east wall of the canyon, at upper left. Photo from University of California Water Resources Center Archives.

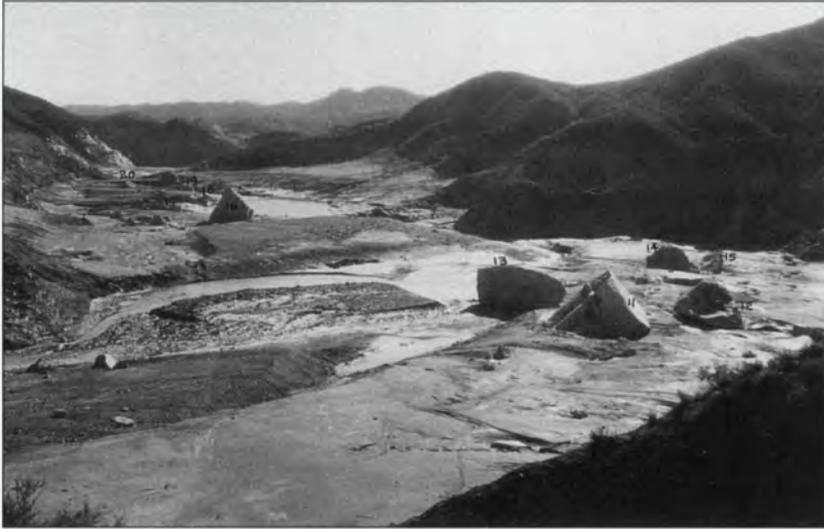
Figure 29 (upper) - Ground view of Blocks 13, 14 and 11 (left to right), as seen from across the canyon 400 yards downstream of the dam the morning after the failure. Note the enormous bank of schist silt and detritus upon which the blocks were deposited. Photo from University of California Water Resources Center Archives.

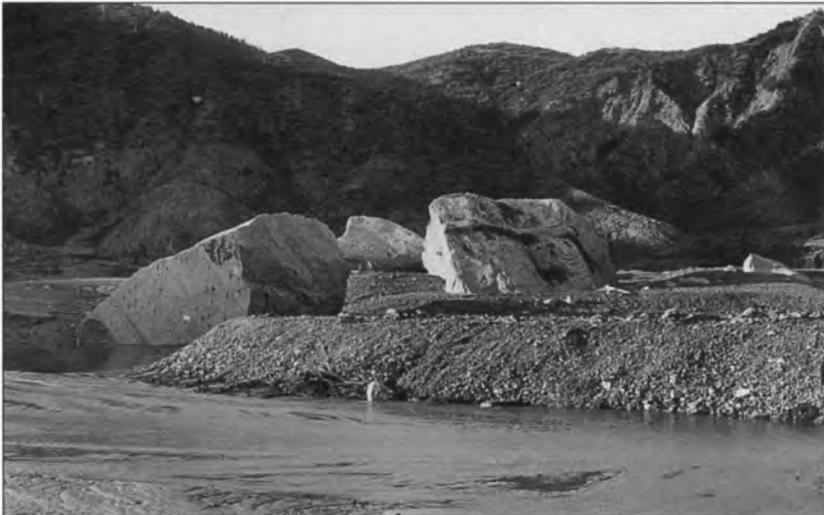
Figure 29 (lower) - Portion of panorama of displaced dam blocks, looking downstream from a position about 300 yards downstream of the dam. Block designations are those of the Governor's Board of Inquiry (Figure 9). Photo from Lippincott Collection, University of California Water Resources Center Archives.

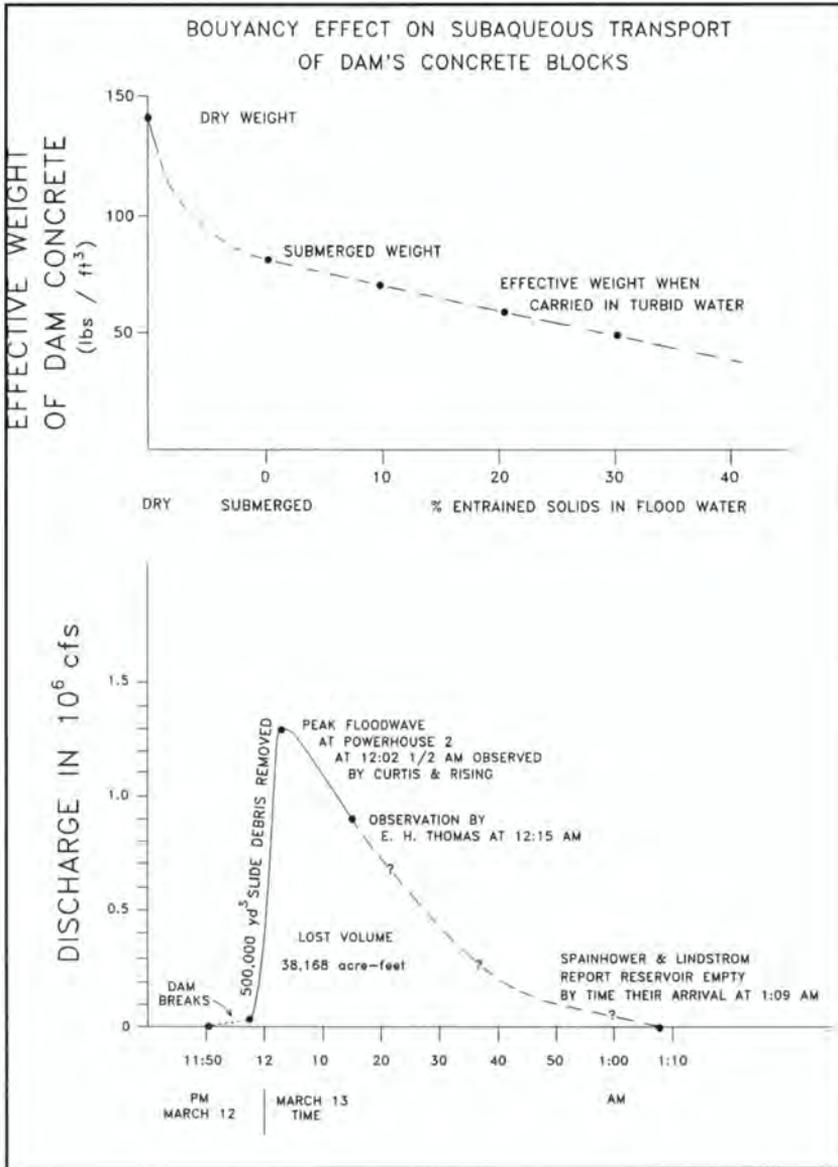
Figure 30 - Preliminary evaluation of flood wave turbidity effects on buoyancy of the dam's concrete blocks. Although heavy when dry, tests of the dam's concrete show it to have a void ratio of around 13 percent. Post-failure photos also suggest that the blocks were saturated, as they wept considerable moisture for days following the failure. If saturated, and immersed in turbid flood waters, the effective weight of the blocks was reduced by as much as 67 percent.

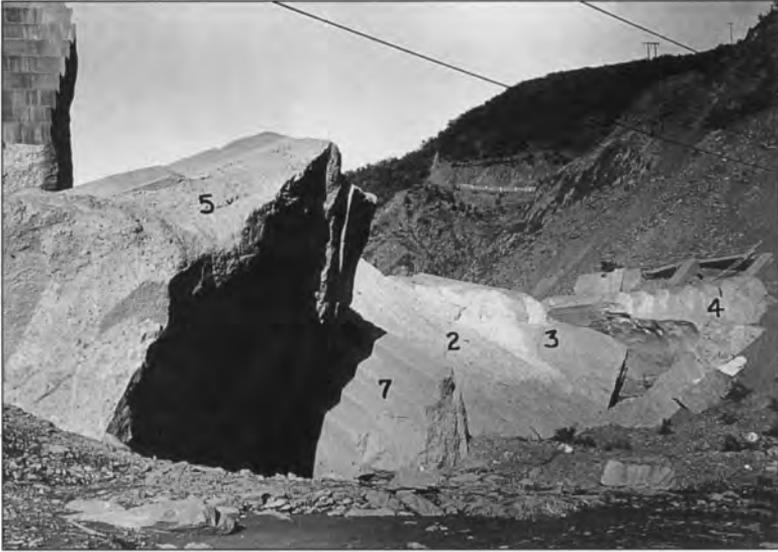
Figure 31 (upper) - Ground view looking upstream on east side of Block 1 at Blocks 5, 7, 2, 3 and 4. The scour hole containing Blocks 2 and 3 must be approaching 60 feet deep in order to have accounted for their buried mass. Huber Collection, University of California Water Resources Center Archives.

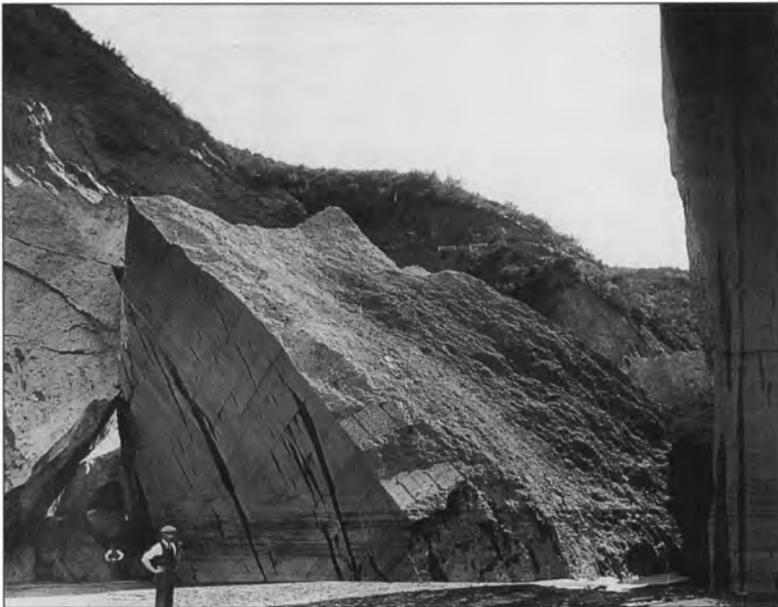
Figure 31 (lower) - Ground view looking at upstream face of Block 2 and east edge of Block 1, showing silt scour lines approximately 15 feet above the infilled reservoir floor. These water lines suggest that Blocks 2/3/4 toppled over late in the flood sequence, when only 20 to 25 feet of water remained in the reservoir. Huber Collection, University of California Water Resources Center Archives.

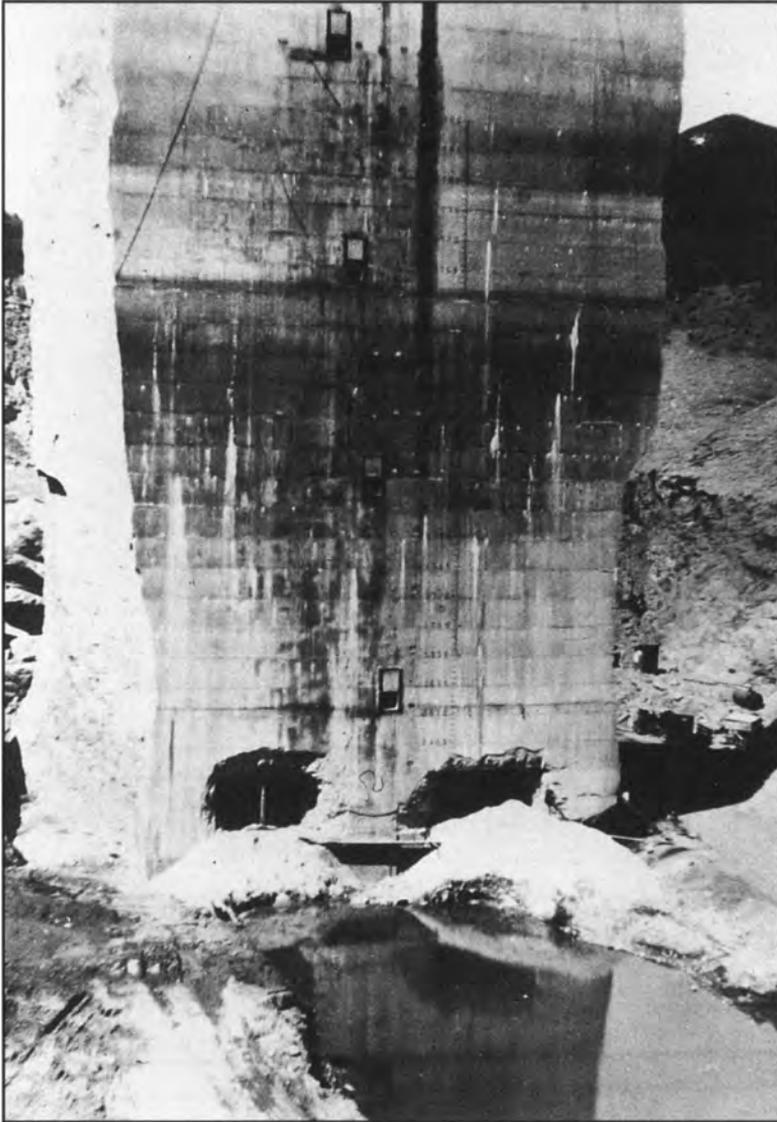
Figure 32 - Detail of base of Block 1 during preparations for demolition in August 1929. The upstream heel of Block 1 was excavated, filled with explosives and detonated a short time later, forcing the dam's remains to topple backward and split apart along near-horizontal cold (pour) joints. Note the elevations painted in black every five feet running down the upstream face. The gage ladder (Figure 24) had been affixed to the dam just to the left of these numerals. Photo by permission of Ventura County Museum of History & Art.
