**100 Years of Embankment Dam
Design and Construction
in the
U.S. Bureau of Reclamation**

Bureau of Reclamation History Symposium
at
University of Nevada - Las Vegas
June 18-19, 2002

Richard Lyman Wiltshire, P.E.
Civil Engineer, Principal Designer
Geotechnical Services Division, Group 1
Technical Service Center
Bureau of Reclamation
U.S. Department of the Interior
Denver, Colorado

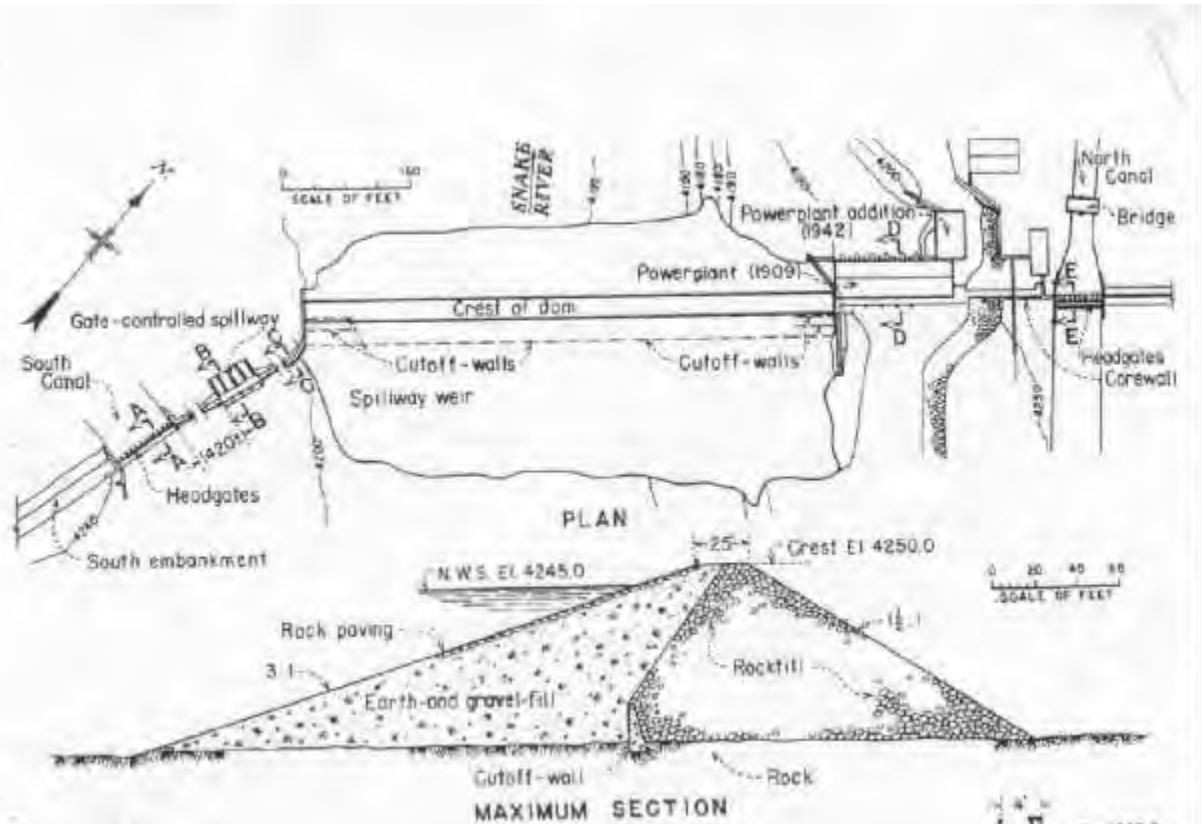
Figure 3 - Minidoka Dam Plan and Section

Period I embankment dams utilizing this type of cross-section included: Avalon, Clear Lake, Minidoka, and McMillan Dams and Elephant Butte Dike. Avalon and McMillan Dams, both on the Pecos River near Carlsbad, New Mexico, were actually the second or third reconstructions of earlier dams that had failed by overtopping during floods that breached both dams. Neither dam included a transition/filter zone between the earthfill and rockfill zones, which was added to later dams of this type. Avalon Dam also had a part sheet-pile, part concrete core/cutoff wall the full height of the dam. The upstream slope of these dams was typically 3:1 that was often steepened to 2:1 above the full reservoir level, and the downstream slope was typically 1.5:1. The relatively high cost of using rockfill material with the equipment then available was the reason that few of this type of embankment dam were constructed by Reclamation. The failure of several non-Reclamation dams of this type during this period probably contributed to the decision to stop building this type of dam.

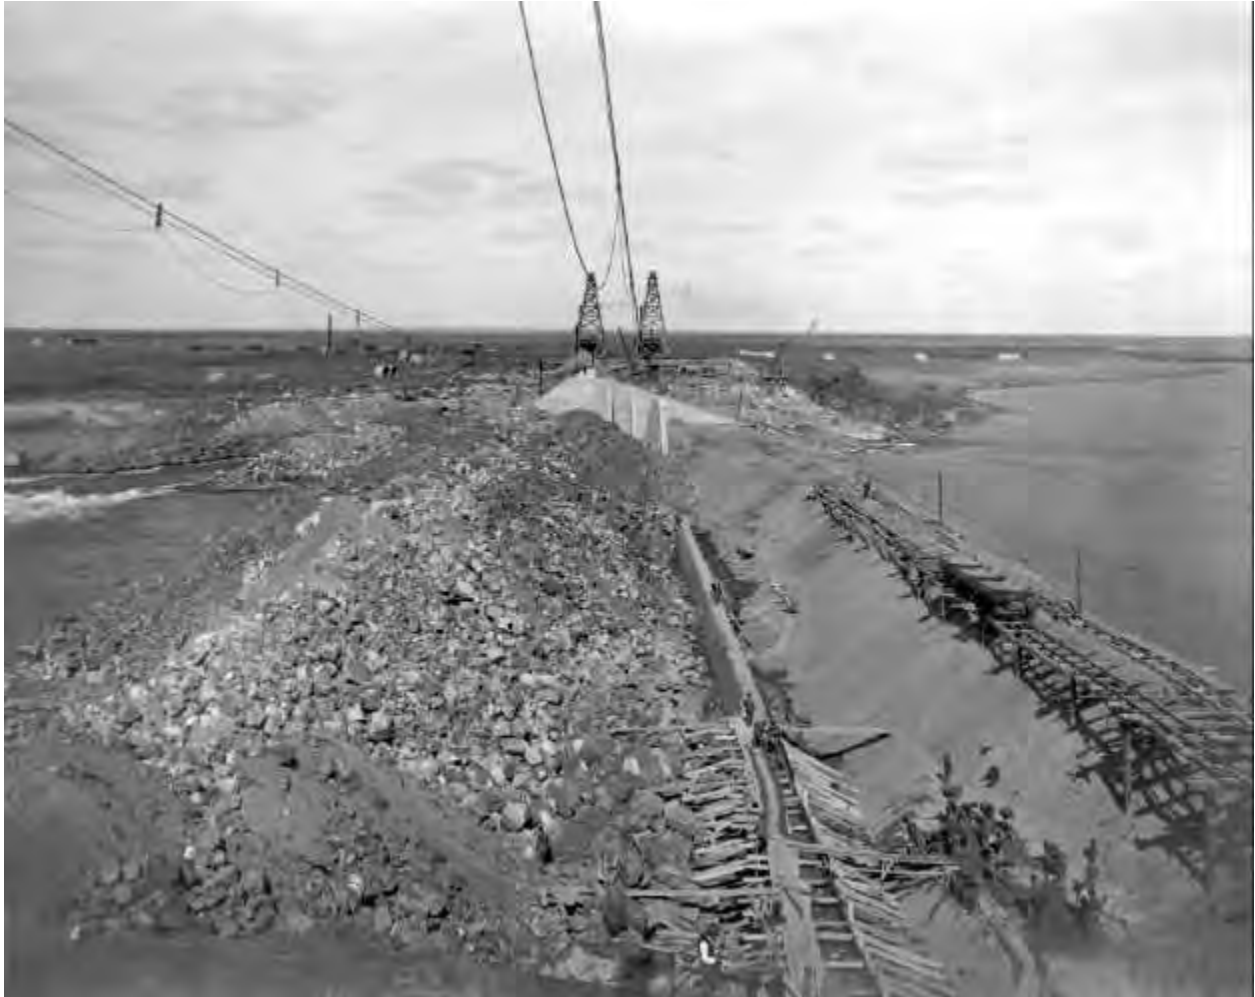
Figure 4 - Minidoka Dam Construction

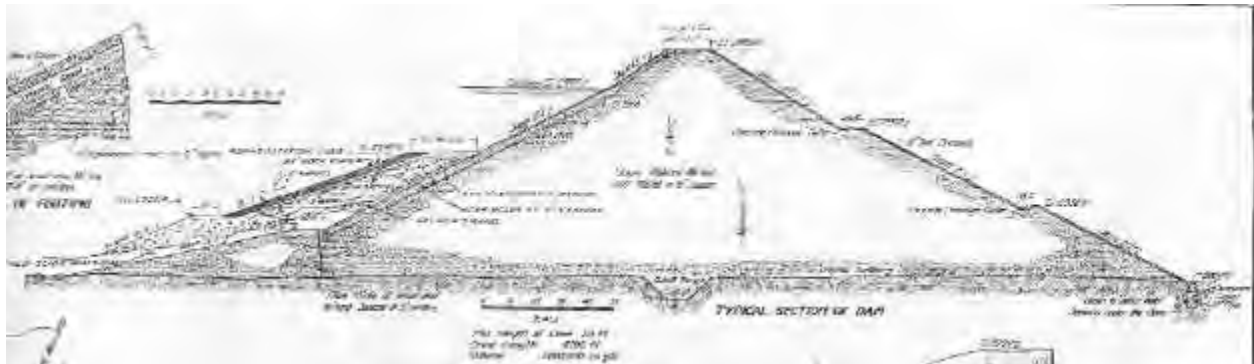
to flatten the upper upstream slope and flatten the upper downstream slope, moving the crest downstream (see **Figure 5** below).

Figure 5 - Belle Fourche Dam Section

Belle Fourche Dam (locally called Orman Dam) is located on Owl Creek about 10 miles northeast of Belle Fourche, South Dakota, and was the most notable embankment dam constructed by Reclamation during Period I. The dam was constructed 115 feet high above its streambed with a crest length of 6,262 feet, an earthfill volume of 1,783,000 yd³, impounded a 192,000 acre-foot off-stream reservoir and a water-surface area of about 8,000 acres, and was fed by a 6-mile-long canal that conveyed a maximum of 1,600 ft³/s of water diverted by a diversion dam on the Belle Fourche River. Information on the embankment's as-built slopes is given above. The original upper slopes shown on the 1905 Belle Fourche Dam design drawings were 1:1 instead of 1.5:1 upstream and 1.75:1 instead of 1.655:1 downstream. The decision was made during construction

The greater steepness of the upstream slope, compared to the other embankments designed and built by the Service during Period I was an important difference. Construction under contract No. 73 awarded to Orman & Crook of Pueblo, Colorado, began in November 1905, but work was suspended in early 1908 when Orman & Crook went into bankruptcy. Construction resumed in April 1908 under a new contract with the National Surety Company of New York, who was the “bondsman” for Orman & Crook. The National Surety Company subcontracted with several private companies to perform the construction and the dam was completed on June 30, 1911. The total cost, including engineering, construction, cement, and general expenses, was about \$1,299,000. An article on Belle Fourche Dam by Project Engineer Raymond F. Walter was published in *Engineering Record* in March 1906 [14]. A second article on the dam by Resident Engineer O. T. (Oliver) Reedy (Associate Member, ASCE) was published in *Engineering Record* in April 1910 [15], describing the early plans for the project and the construction to date (early 1910) on the dam and appurtenant structures. Some of the more unique or informative details related to Belle Fourche Dam’s design and construction are discussed below.

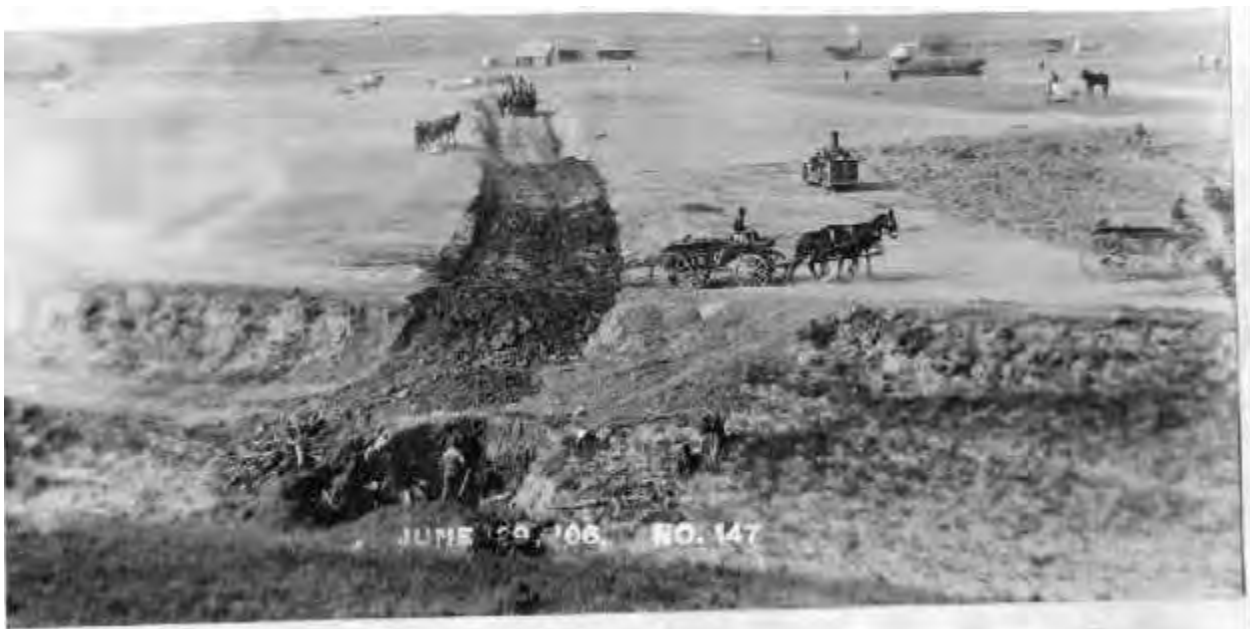
Figure 6 - Belle Fourche Dam - Cutoff Trench Construction

The cutoff trench was excavated by horse-drawn “wheel scrapers” and a locomotive crane, using

a ½-yd³ clamshell bucket, after which the trench was backfilled with compacted “select material” (see **Figure 6** on previous page). The earthfill material in the borrow area(s) was excavated by 70-ton and 75-ton steam shovels with a 2½-yd³ bucket/dipper and was dumped into the 4-yd³ Western side-dump cars (see **Figure 7** below). The trains of 10 to 13 side-dump cars (a total of about 60 side-dump cars were used) were pulled by 18-ton Dinkey locomotives that hauled the trains about ¾-mile to the embankment, up a maximum grade of about 4 percent onto the embankment surface. The 36-inch gage train tracks and wooden ties were moved every third layer as the embankment rose in height. Three-horse-team 1¼-yd³ dump wagons, filled by Western graders pulled by traction engines, were also used to haul earthfill from some of the upstream borrow pits.

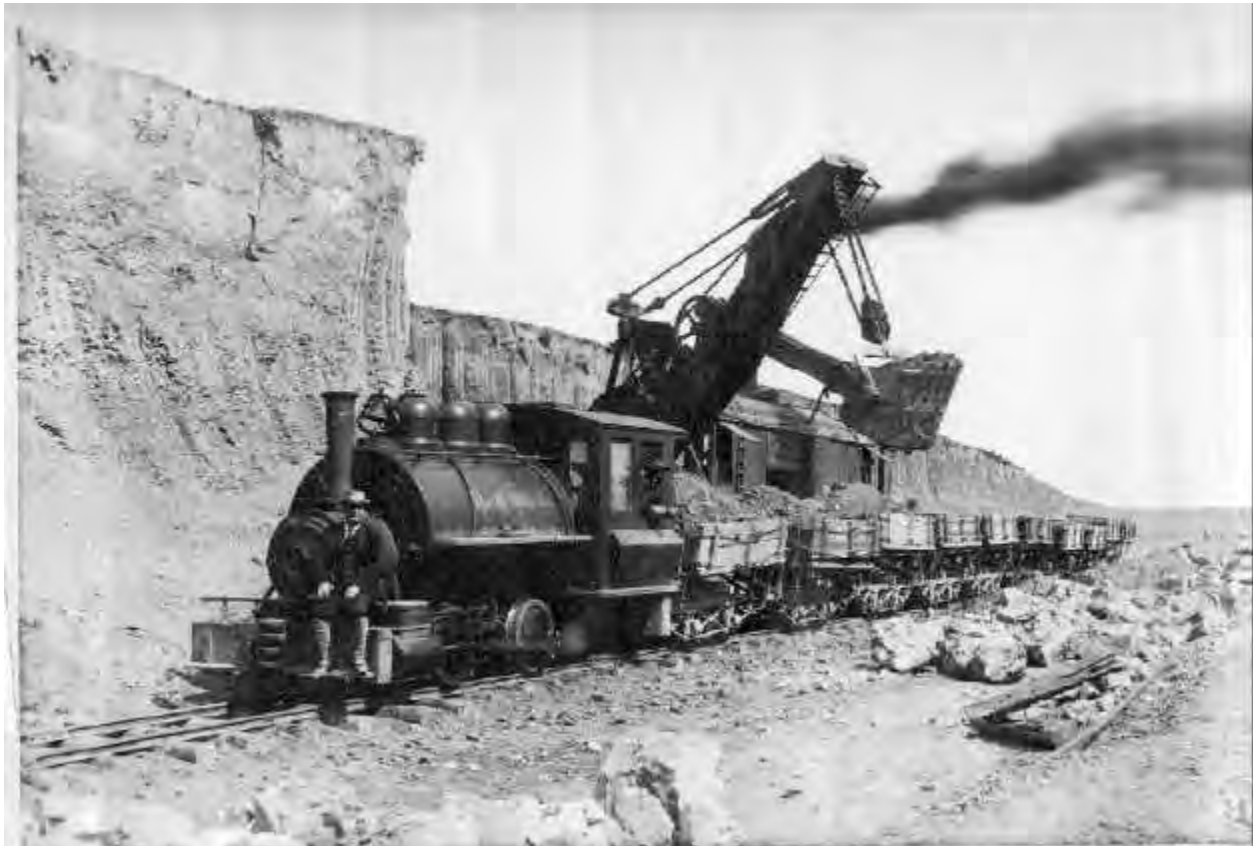
**Figure 7 - Belle Fourche Dam
Steam Shovel, Dinkey Locomotive, and Train of Side-Dump Cars in Borrow Pit**

the size of the equipment currently used to construct embankment dams. Compare the end-dump truck in **Figure 24** and its 35 yd³ capacity to the train of 4 yd³ side-dump cars used to construct Belle Fourche Dam in 1909 shown in **Figure 7**. Also compare the large excavator in **Figure 24** and its 12 yd³ bucket with steam shovel at Belle Fourche Dam with its 2½-yd³ bucket shown in **Figure 7**. During Period V, synthetic materials such as high-density polyethylene (HDPE) and polypropylene were developed into new products, such as corrugated pipe, geomembranes, and geotextiles, that were promptly put to use on embankment dams where judged appropriate. New types of equipment related to these new materials and products were developed, and quality control tests, testing equipment, and detailed test procedures were developed, with Reclamation's significant participation in these developments.

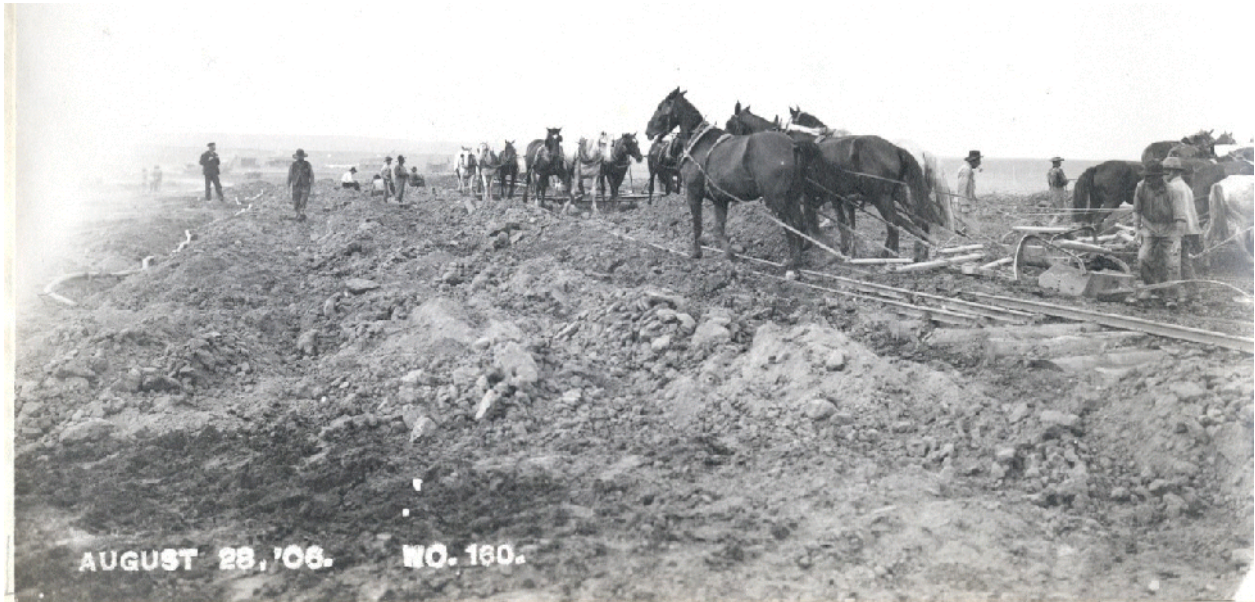
Figure 8 - Belle Fourche Dam - Embankment Fill Construction

Four-horse-team Fresno scrapers were used to move the dumped earthfill a maximum distance of 50 feet away from the tracks, and ordinary four-horse-team road graders ran over the material deposited by the scrapers to spread and level the layer (see **Figure 8** on next page). The layer of earthfill was thoroughly wetted, if necessary, using a 2-inch hose to apply water pumped up from wells or small reservoirs. If the earthfill was compacted immediately

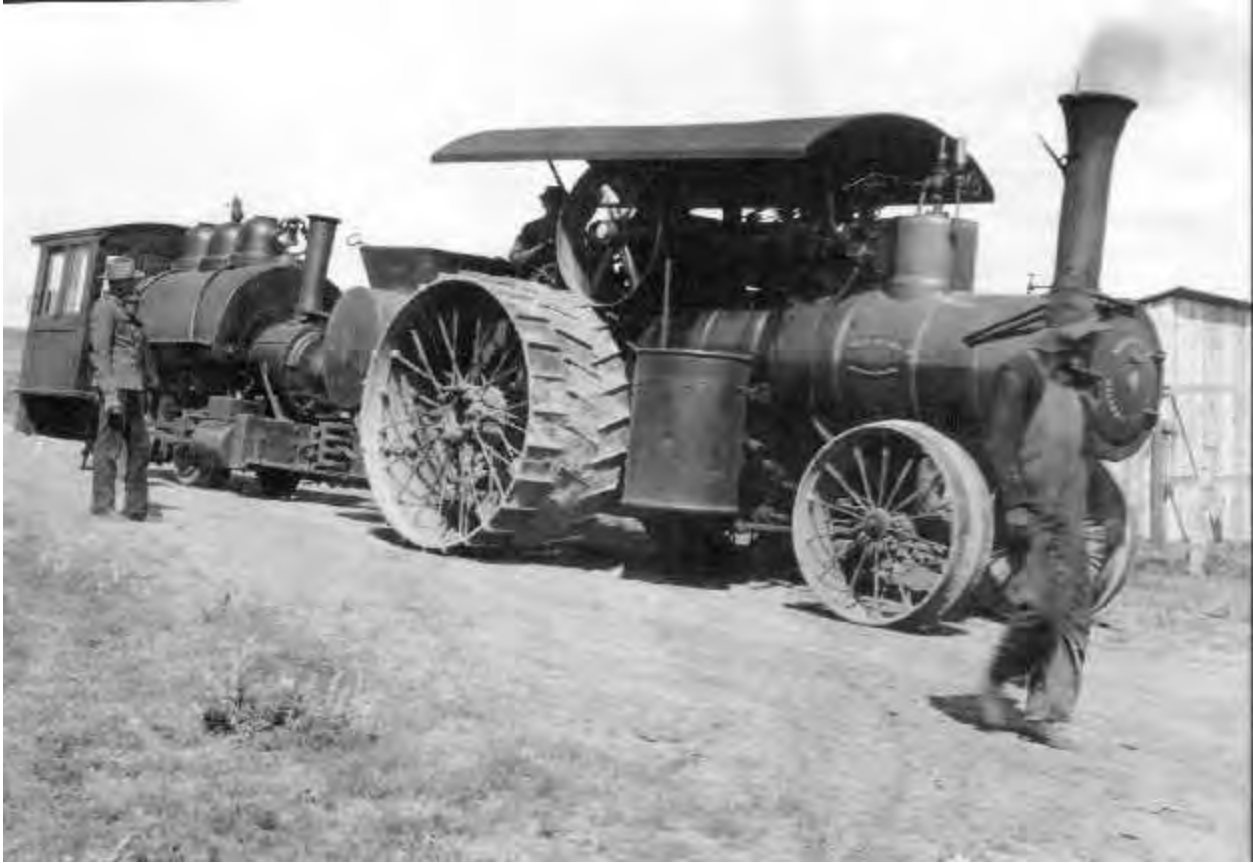
Figure 9 - Belle Fourche Dam - Traction Engine Hauling Dinkey Locomotive to Damsite

after being placed on the fill, little if any water needed to be applied. The specifications required that the earthfill material be placed and rolled in 6-inch layers using steam rollers weighing not less than “200 pounds per linear inch of roller rim.” According to O.T. Reedy’s article, one of the rollers used was a 12-ton roller with a 4-foot rolling base. According to the Belle Fourche Project History [17], an “8-ton asphalt dirt roller with smooth wheels” was also used, but it often became stuck on the slick surface of the embankment. However, most of the compaction was accomplished by four 32-horsepower 18-ton and 21-ton traction (steam) engines, with the rear wheels having been widened to create a 6-foot-wide “rolling base.” The traction engines accomplished the compaction more quickly due to their greater power (see **Figure 9** on next page).

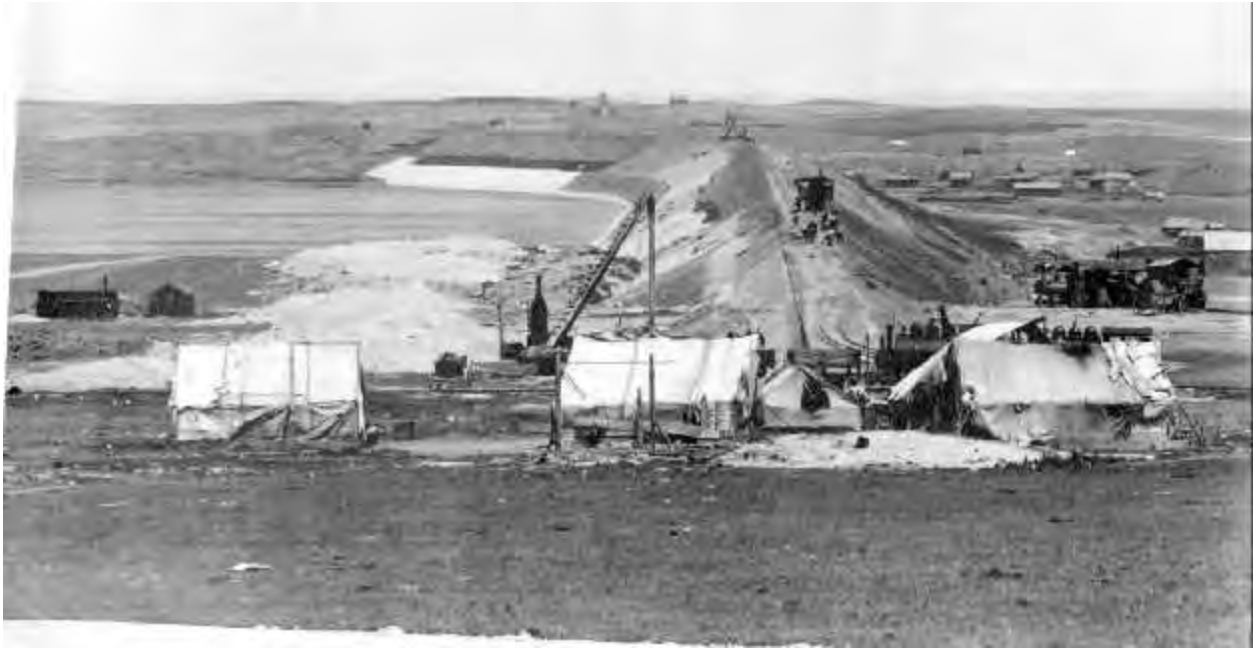
Figure 10 - Belle Fourche Dam - Embankment from Right Abutment

Another unique feature of the dam's design was the upstream slope protection. The nearest rock quarry was located 32 miles away and the sandstone's quality was considered poor, together causing its use to be rejected. The selected upstream slope protection consisted of 8-inch-thick concrete blocks/slabs that measured 5 feet by 6½ feet, and weighed about 3,000 pounds each. A concrete footing wall was constructed at the bottom of the 2:1 slope and the bottom course of blocks rested against this wall. Along the center portion of the embankment, the concrete footing wall was buttressed by 10-inch-diameter 16-foot-long timber piles driven into the earthfill on 3-foot centers. The concrete blocks were placed on a 24-inch-thick bed of gravel using stiff-leg 3-ton-capacity traveling derricks with 25-foot masts and 50-foot booms operated by 20-horsepower hoisting engines. The blocks were moved into place with the derrick and were then levered and hammered into place. **Figure 10** below shows the nearly-completed dam embankment from the

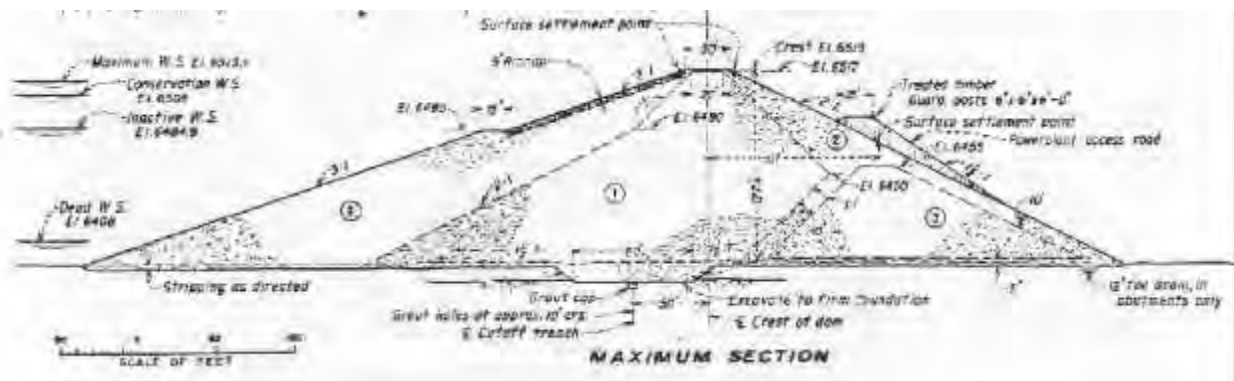
Figure 11 - Fontenelle Dam Section

Fontenelle Dam, completed in 1964 with a maximum height of 128 feet above streambed, included: irrigation canal outlet works in both abutments, a river outlet works near the middle of the dam capable of passing 18,700 ft³/s, a hydroelectric powerplant, and a right abutment overflow spillway of 20,000 ft³/s capacity at full pool. The river outlet works was large because it was less costly than increasing the size of the spillway. The embankment cross-section is shown in **Figure 11** below. The embankment zoning included: the zone 1 core, the zone 2

chimney and blanket drain of selected (pit run alluvium) sand, gravel, and cobbles, and a zone 3 miscellaneous fill that was completely enclosed within the Zone 2. The surface of the bedrock foundation was far more broken than had been anticipated, so the cutoff trench was deepened by 6 feet. The foundation and abutments were grouted by a single-row grout curtain installed through a grout cap. Grout takes in the upper 65 feet of the foundation were very large and a

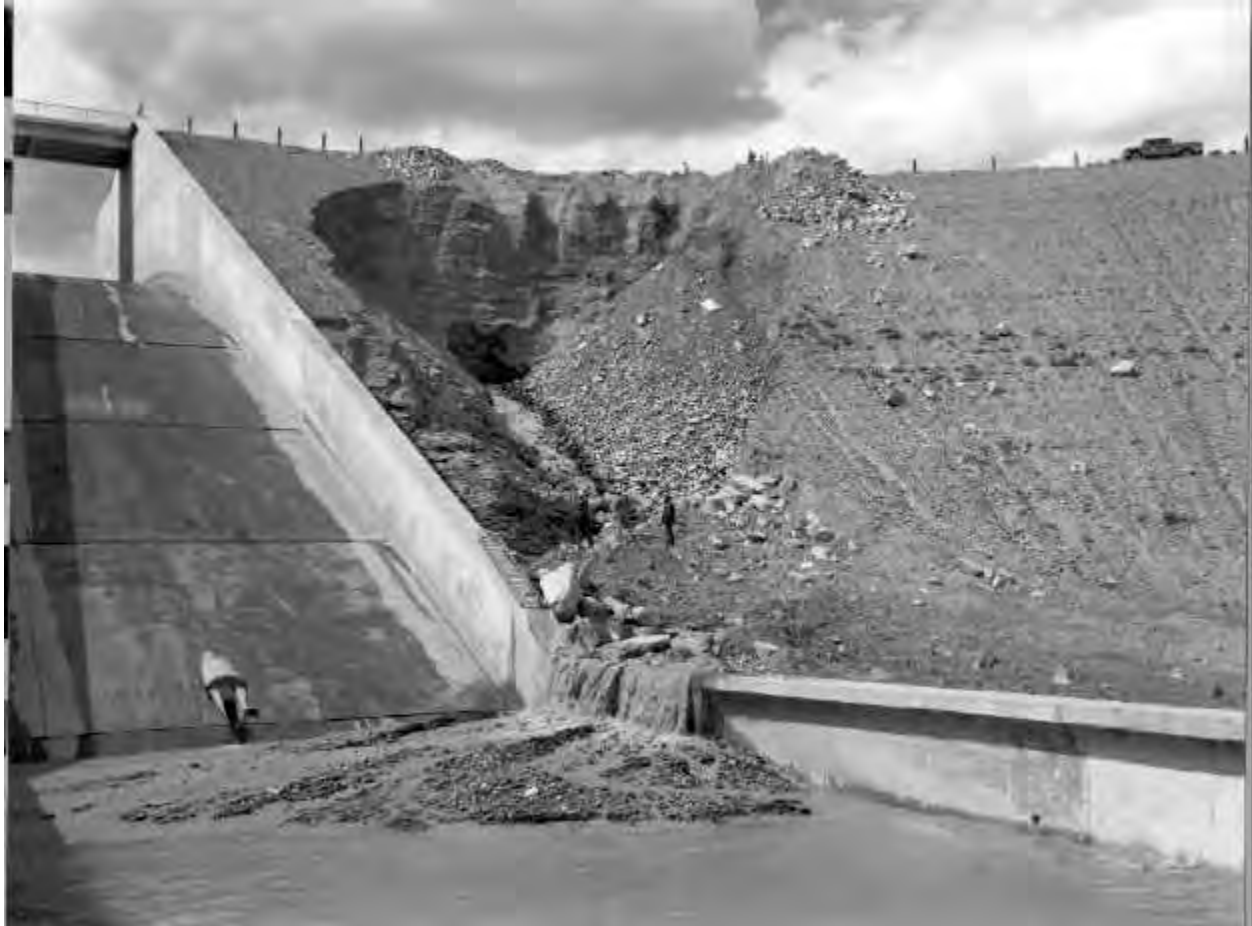
Figure 12 - Fontenelle Dam - Large Sinkhole on Downstream Slope

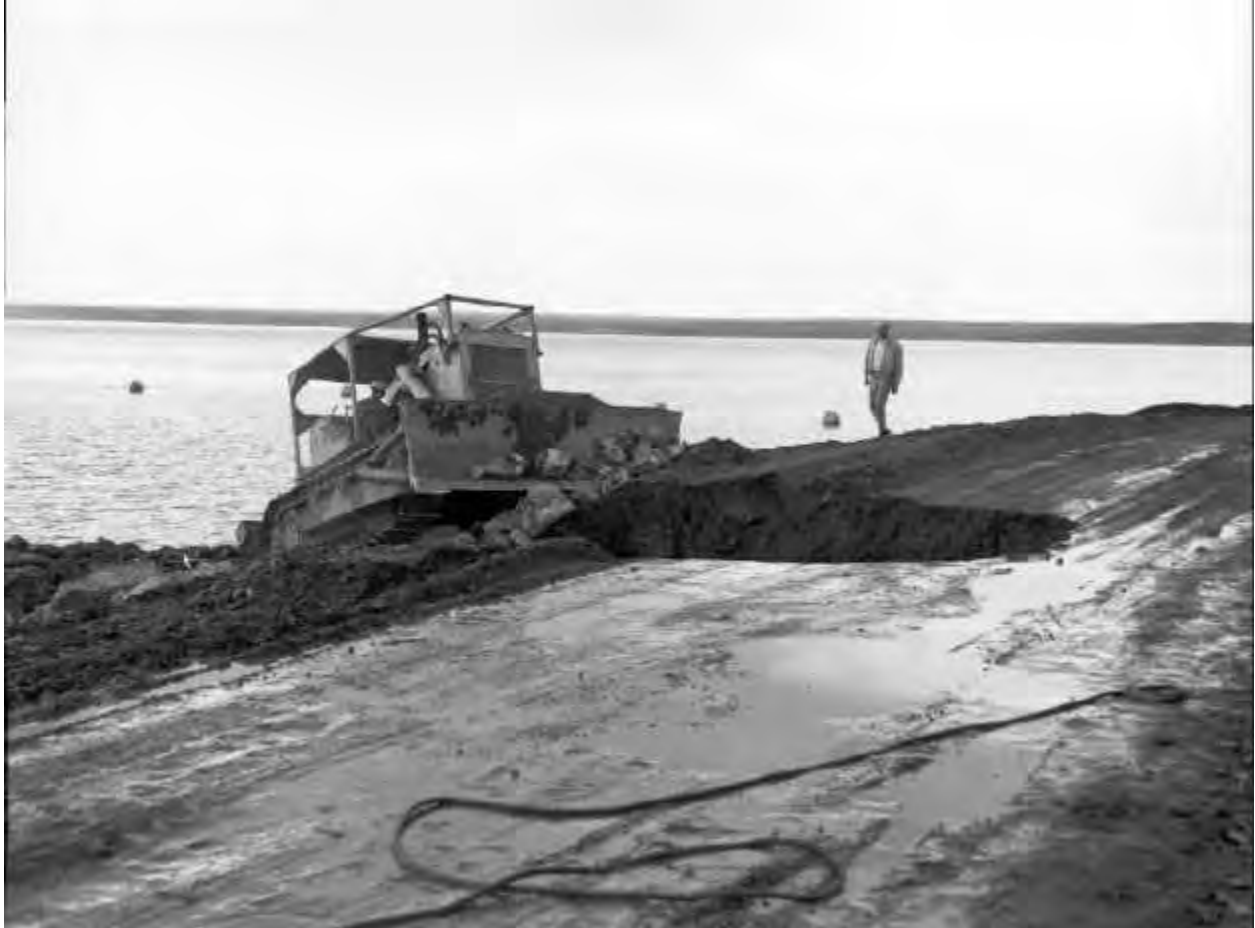
Figure 13 - Fontenelle Dam - Crest Sinkhole

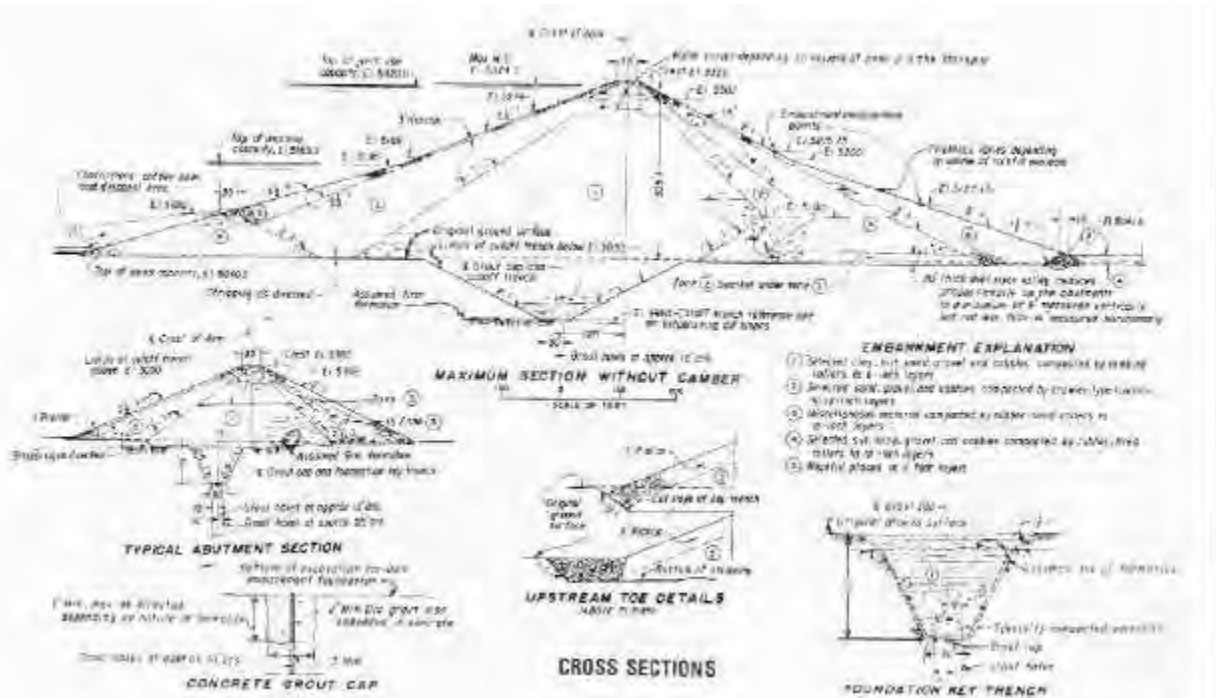
Figure 14 - Teton Dam Sections

Teton Dam was constructed between February 1972 and November 1975, with a maximum height of 305 feet above the streambed. The embankment cross-section was remarkably similar to that of Fontenelle Dam (see **Figure 14** below). The wide zone 1 core consisted of silt, flanked

upstream and downstream by zone 2, which consisted of (pit-run alluvium) selected sand, gravel, and cobbles. There was also a zone 3 miscellaneous earthfill zone downstream, with zone 2 constructed as a chimney filter/drain and as a 20-foot-thick drainage blanket beneath the zone 3 and up the abutments. The outlet works at Teton Dam consisted of the river outlet works with a capacity of 3,400 ft³/s and an auxiliary outlet works with a capacity of 850 ft³/s. The construction schedule required that the river outlet works be operational by May 1, 1976, but the contractor was behind schedule and only the auxiliary outlet works were operational to control reservoir filling.

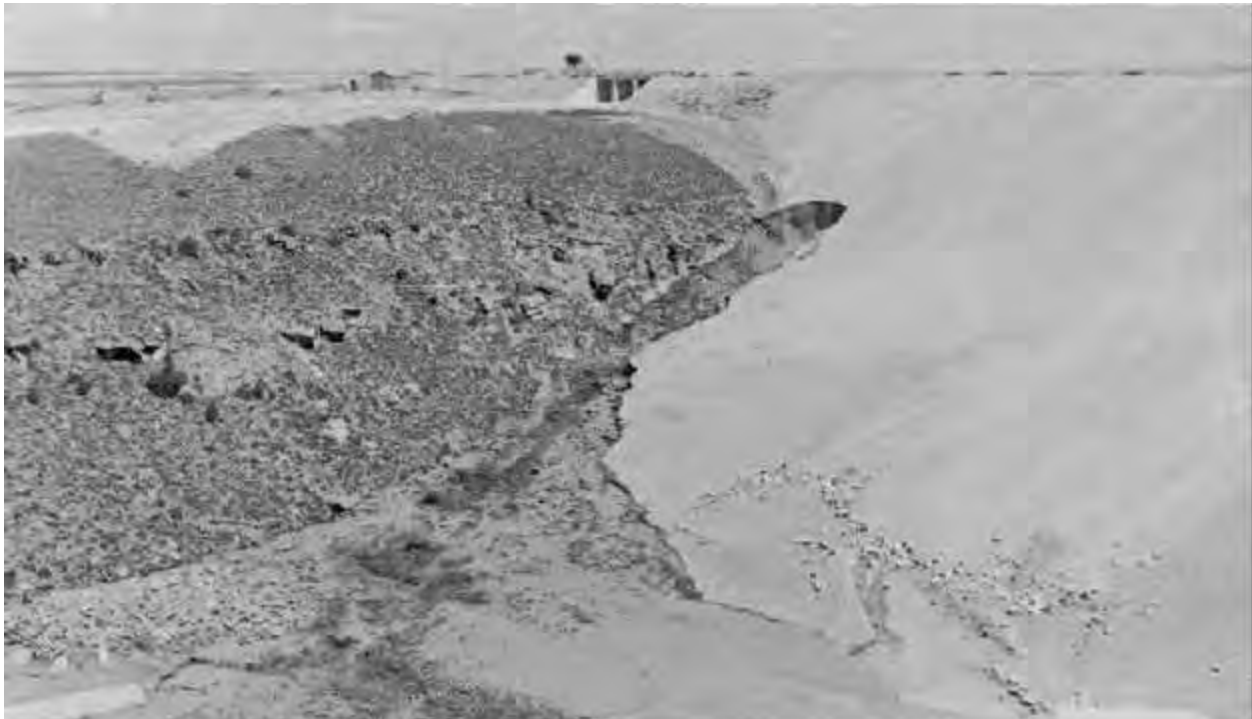
Figure 23.—Dozers lost in leak at El. 5200.

Figure 15 - Teton Dam - Downstream Sinkhole at About 11:20 a.m.

about 2 ft³/s. The lower leak at elevation 5045 was estimated to be flowing 40 to 50 ft³/s at about 9:30 a.m. Between 10:00 and 10:30 a.m., a wet spot was observed on the downstream slope of the dam at elevation 5200 and about 15 to 20 feet from the right abutment. The wet spot quickly increased to a flow of 10 to 15 ft³/s and was eroding the material on the downstream slope. At about 10:30 a.m., a loud sound (roar) was heard, followed by the sound of rapidly running water. At about 11:00 a.m., a whirlpool formed in the reservoir about 150 feet from the right abutment and its diameter rapidly began to expand. By about 11:20 a.m., attempts to bulldoze rockfill into the opening (as had been done at Fontenelle Dam) proved futile (see **Figure 15** on previous page).

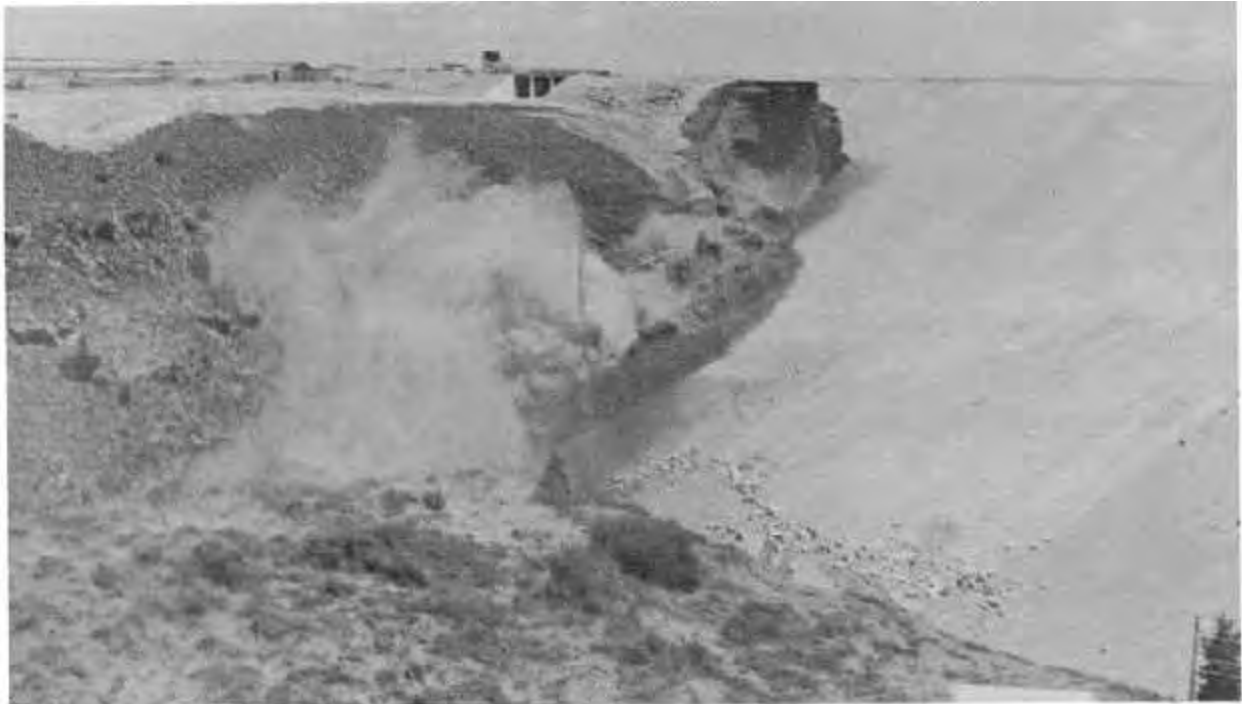
Figure 27.—Dam crest breaching 11:55 a.m., June 5, 1976.

Figure 16 - Teton Dam - Crest Collapsed at 11:55 a.m.

A sinkhole developed on the downstream slope shortly before the embankment crest collapsed at 11:55 a.m. (see **Figure 16** above), and the dam was breached two minutes later at 11:57 a.m. (see **Figure 17** on next page). This sequence of observed new seepage, wet spots, erosion, sinkhole, whirlpool, crest collapse, and embankment breaching took only five hours from start to finish and the complete release of the reservoir followed. By 5:00 to 6:00 p.m. that same day, the reservoir had completely emptied.

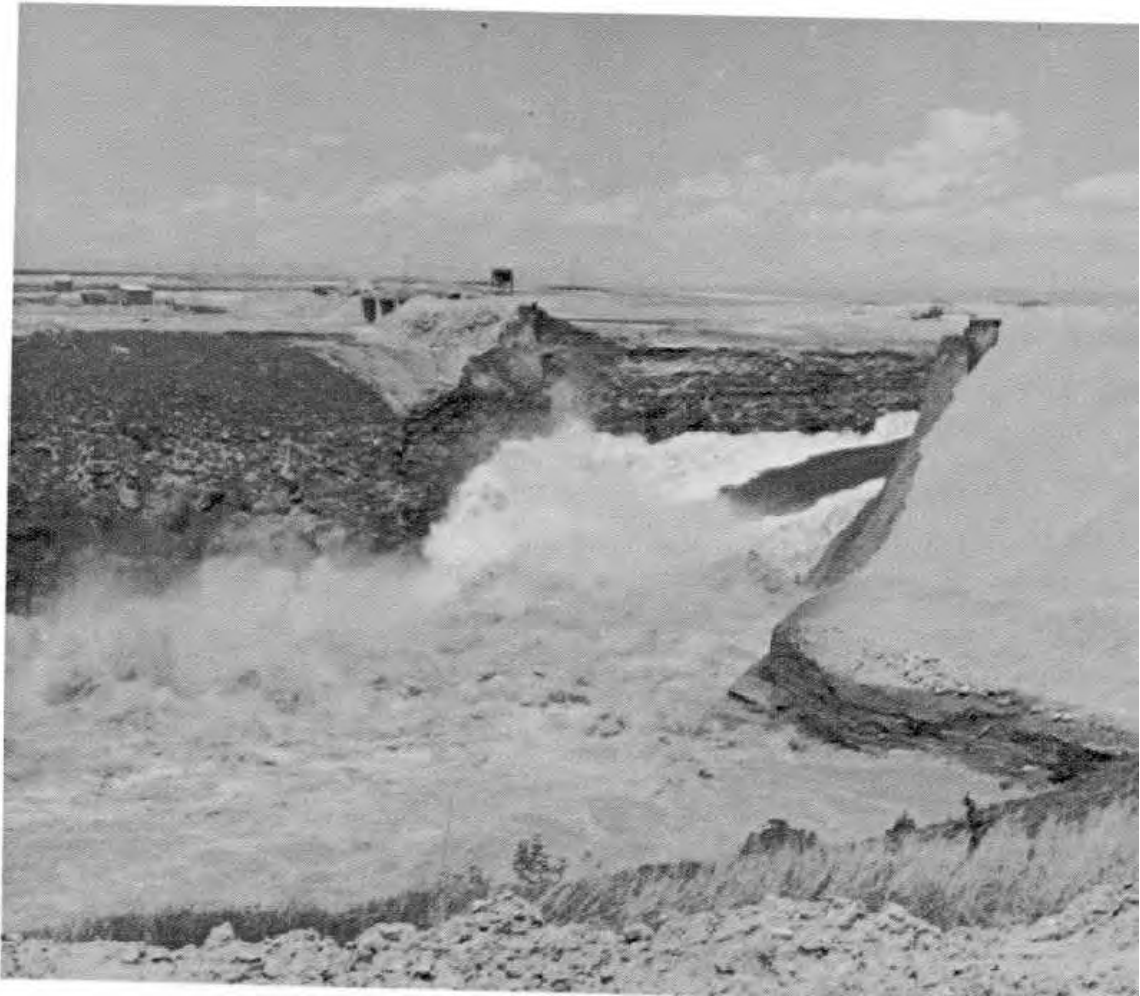
Figure 17 - Teton Dam - Dam Completely Breached

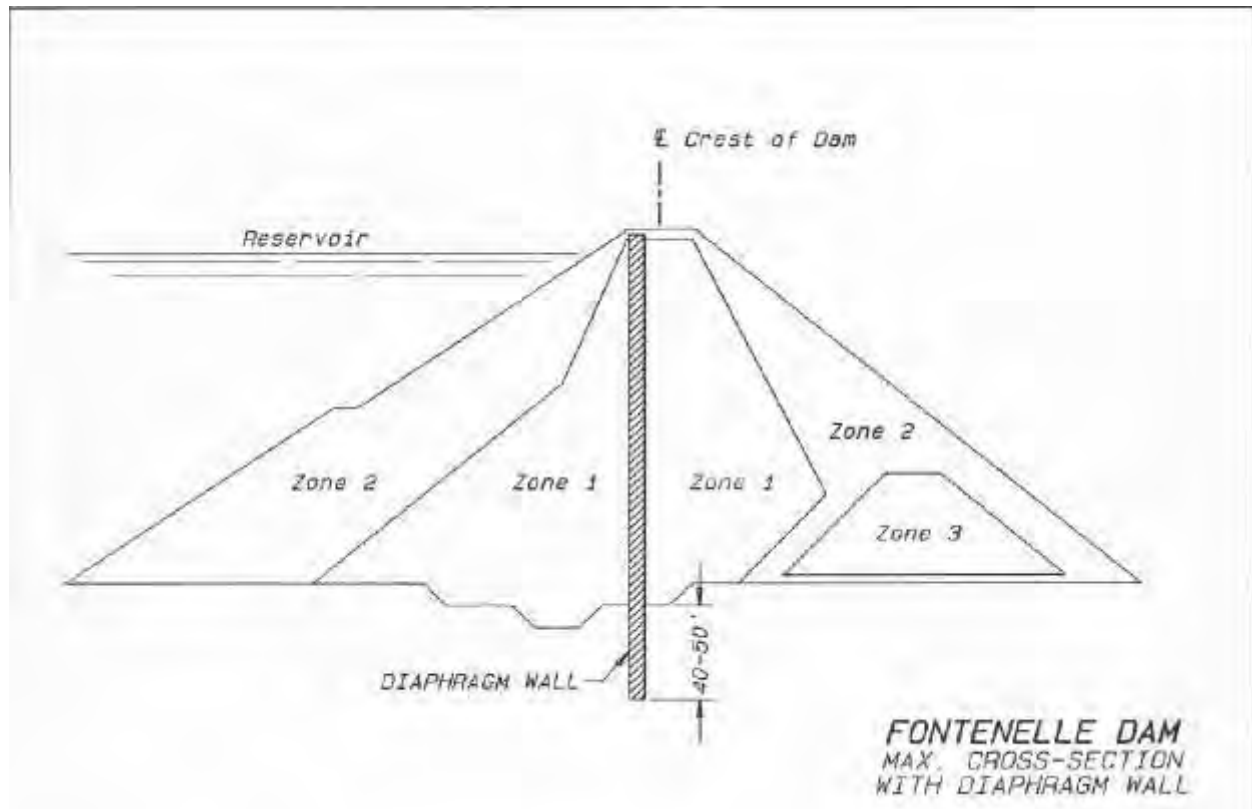
Figure 18 - Fontenelle Dam - Section of Embankment with Diaphragm Wall

Fontenelle Dam continued to have seepage and internal erosion/piping problems after it was supposedly fixed by the additional abutment grouting performed in 1966. Instrumentation monitoring data in 1983 indicated that a potential dam safety problem was developing, and the decision was made to modify the dam by installing a continuous concrete diaphragm wall through the dam and into the foundation. There were several aspects of the existing Fontenelle Dam embankment's design that were judged to have been partly responsible for the failure of Teton Dam, such as vertical to overhanging abutment cliffs, extensive joints and cracks in the abutments, no processed material placed as a chimney to filter the erodible silty zone 1 core as protection against internal erosion/piping, and silty core material placed directly against open, unsealed bedrock joints, cracks, and crevices. Only one solution was judged to be capable of alleviating all of these potential problems, and construction of a concrete diaphragm wall from the crest of the dam down through the embankment and the upper highly-fractured bedrock was selected as the appropriate modification (see **Figure 18** on next page). The concrete diaphragm wall had to avoid damaging the river outlet works near the middle of the embankment and the spillway on the right abutment. The concrete diaphragm wall modification was constructed between 1987 and 1989. **Figures 19 and 20** (on two pages after next page) show the rockmilling equipment used to excavate embankment and rock for the diaphragm wall at Fontenelle Dam.

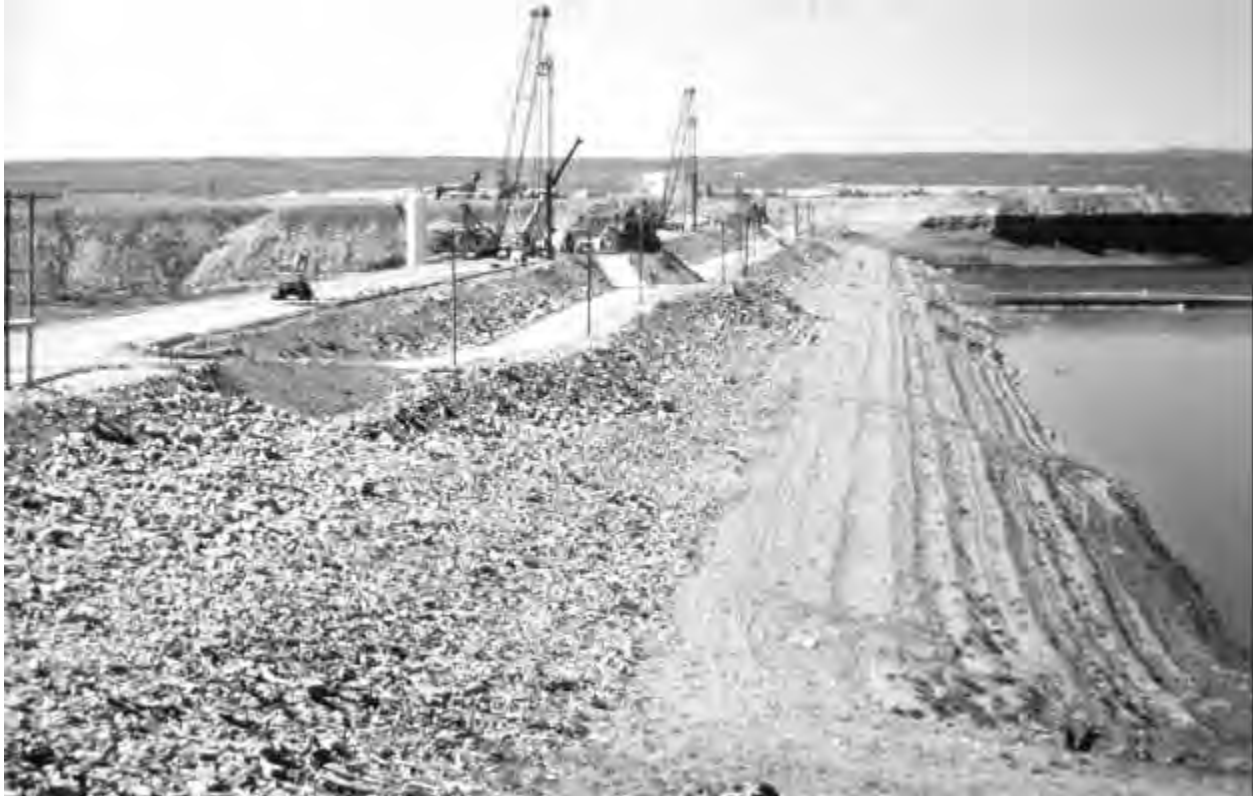
Figure 19 - Fontenelle Dam - Diaphragm Wall Construction

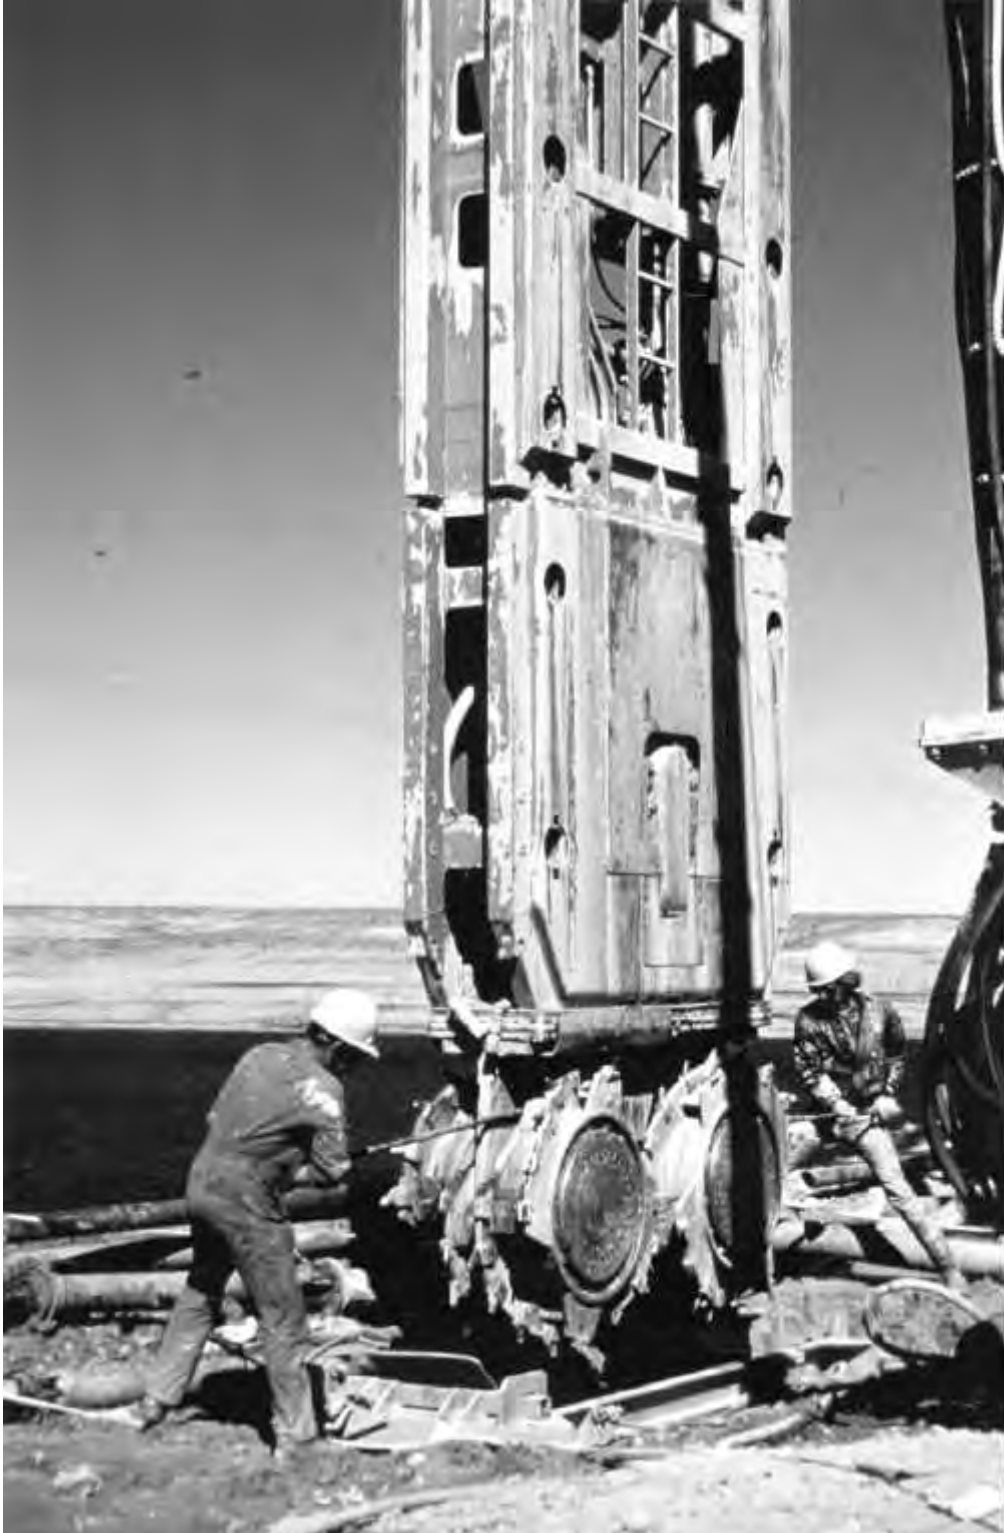
Figure 20 - Fontenelle Dam - Diaphragm Wall - Hydromill Rock Excavator

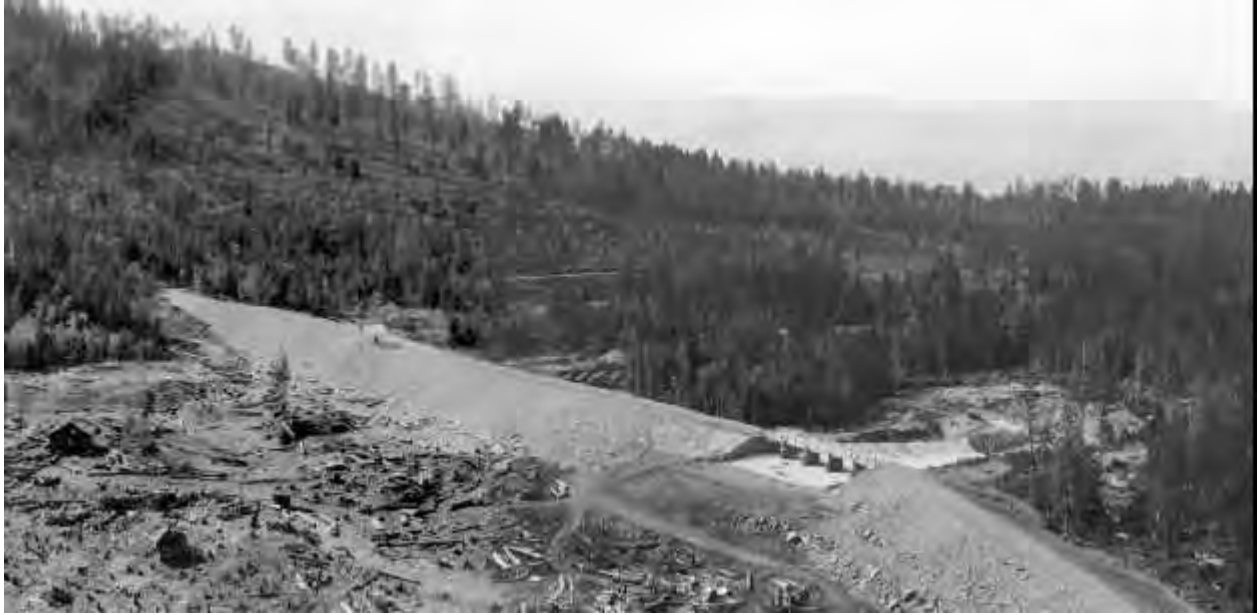
Figure 21 - McDonald Dam - Original Dam in 1920

time. The dam embankment had been constructed by Project Manager/Engineer Frank Crowe (Honorary Member, ASCE) using dumped and sluiced earthfill, with a puddled core created by sluicing the dumped earthfill (see **Figure 21** on page after next page). The embankment and an outwash foundation beneath part of the dam were judged susceptible to liquefaction and excessive deformation. Various alternatives were developed and evaluated, with the final decision reached to completely replace the existing dam embankment, spillway, and outlet works. These modifications were designed by Reclamation who also provided the construction management services. It should be noted that the Construction Engineer for McDonald Dam Modification was on the Design Team. The new McDonald Dam embankment was a completely different embankment design. The new embankment cross-section included: a textured geomembrane covered by earthfill and riprap on the upstream slope, an impervious earthfill zone behind the geomembrane, followed by an inclined processed chimney filter/drain, all of which rest against a large miscellaneous earthfill zone that sits on top of a blanket drain consisting of processed drainage material sandwiched between two layers of the processed filter material. The instrumentation consisted of piezometers in the embankment and foundation, embankment measurement points, and weirs to monitor seepage flows. These McDonald Dam modifications were constructed in 1994-1995 and 1999-2000 (see **Figure 22** also on page after next), after which its behavior during resumed filling of the reservoir in 2000 and beyond went very well [44].
