**100 Years of Embankment Dam
Design and Construction
in the
U.S. Bureau of Reclamation**

Bureau of Reclamation History Symposium
at
University of Nevada - Las Vegas
June 18-19, 2002

Richard Lyman Wiltshire, P.E.
Civil Engineer, Principal Designer
Geotechnical Services Division, Group 1
Technical Service Center
Bureau of Reclamation
U.S. Department of the Interior
Denver, Colorado

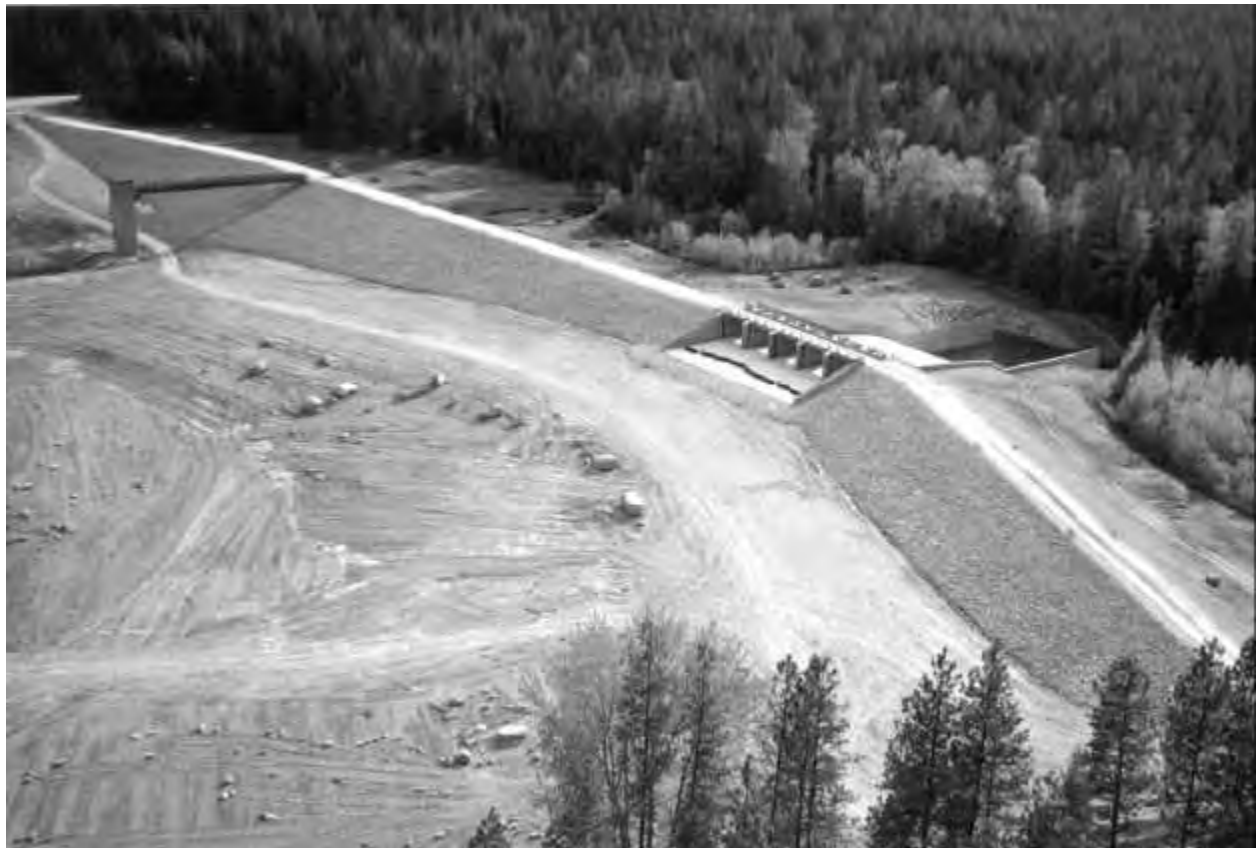
Figure 22 - McDonald Dam - New Dam in 2000

time. The dam embankment had been constructed by Project Manager/Engineer Frank Crowe (Honorary Member, ASCE) using dumped and sluiced earthfill, with a puddled core created by sluicing the dumped earthfill (see **Figure 21** on page after next page). The embankment and an outwash foundation beneath part of the dam were judged susceptible to liquefaction and excessive deformation. Various alternatives were developed and evaluated, with the final decision reached to completely replace the existing dam embankment, spillway, and outlet works. These modifications were designed by Reclamation who also provided the construction management services. It should be noted that the Construction Engineer for McDonald Dam Modification was on the Design Team. The new McDonald Dam embankment was a completely different embankment design. The new embankment cross-section included: a textured geomembrane covered by earthfill and riprap on the upstream slope, an impervious earthfill zone behind the geomembrane, followed by an inclined processed chimney filter/drain, all of which rest against a large miscellaneous earthfill zone that sits on top of a blanket drain consisting of processed drainage material sandwiched between two layers of the processed filter material. The instrumentation consisted of piezometers in the embankment and foundation, embankment measurement points, and weirs to monitor seepage flows. These McDonald Dam modifications were constructed in 1994-1995 and 1999-2000 (see **Figure 22** also on page after next), after which its behavior during resumed filling of the reservoir in 2000 and beyond went very well [44].

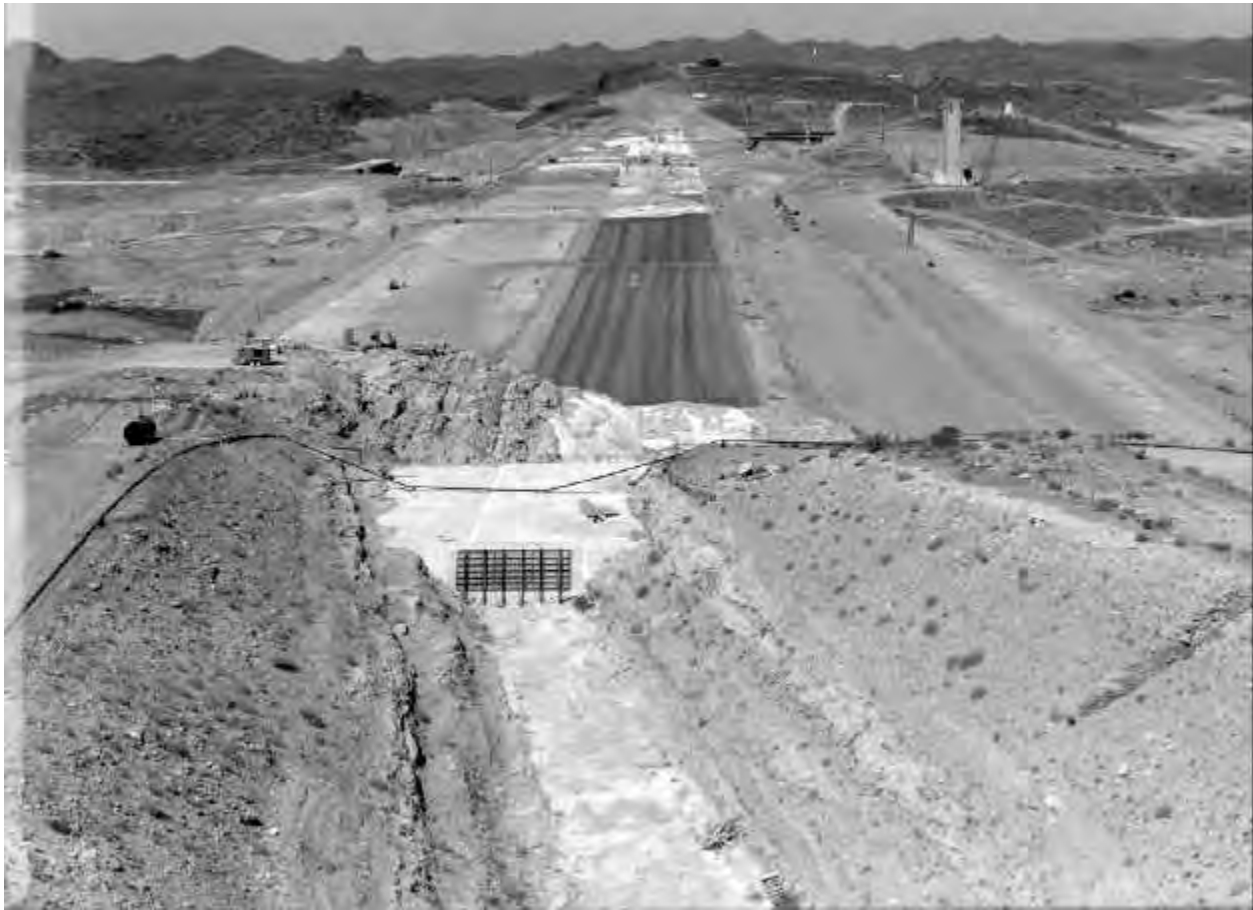
Figure 23 - New Waddell Dam Construction

During Period V, the variety of equipment available for the construction of embankment dams continued to improve in size, power, speed, and efficiency as usual. For example, **Figures 23 and 24** (see below and next page) show the construction of New Waddell Dam (1986-1992) and

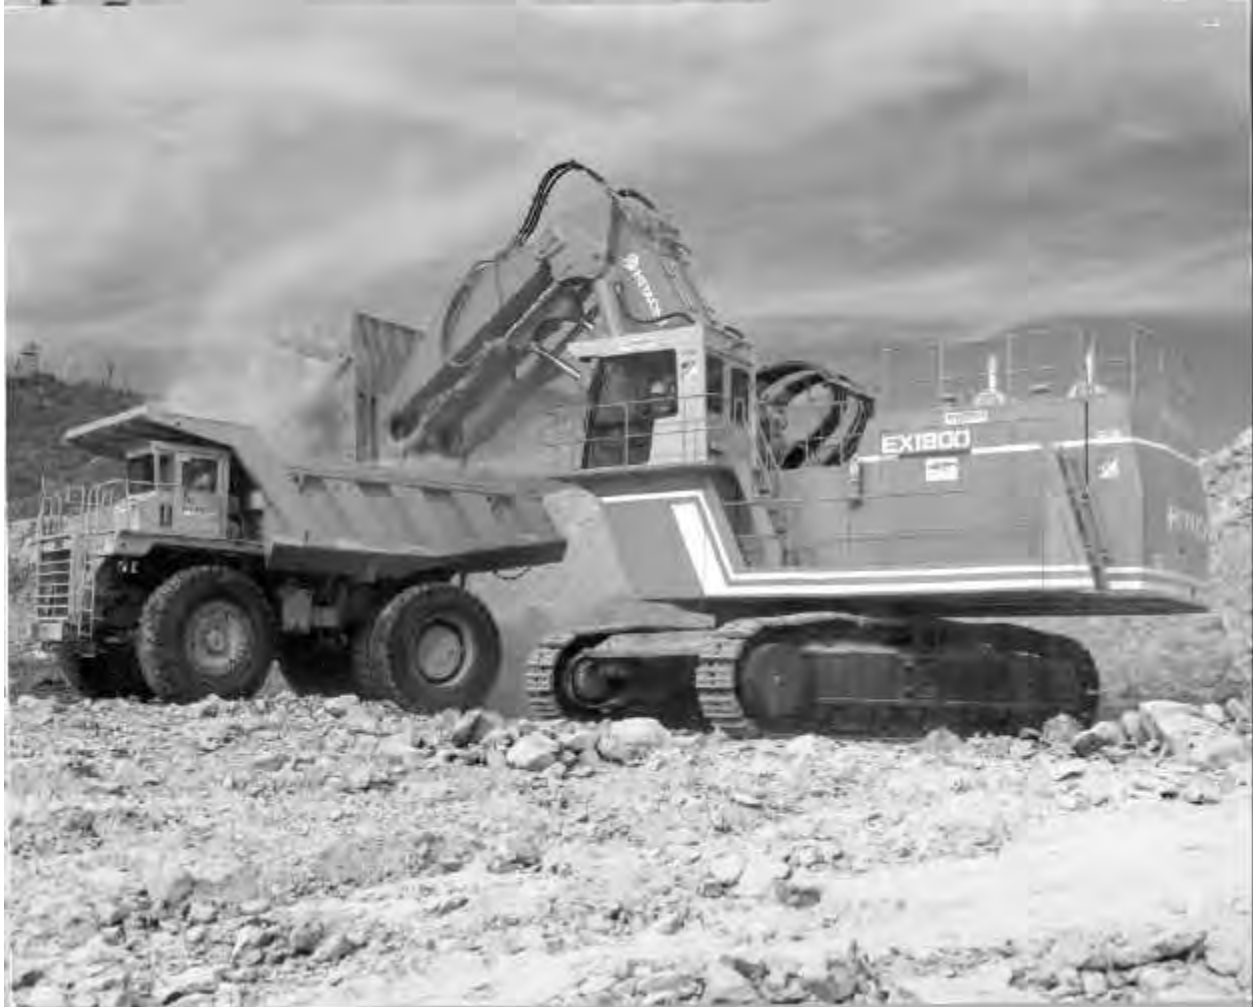
Figure 24 - New Waddell Dam - Construction Equipment

the size of the equipment currently used to construct embankment dams. Compare the end-dump truck in **Figure 24** and its 35 yd³ capacity to the train of 4 yd³ side-dump cars used to construct Belle Fourche Dam in 1909 shown in **Figure 7**. Also compare the large excavator in **Figure 24** and its 12 yd³ bucket with steam shovel at Belle Fourche Dam with its 2½-yd³ bucket shown in **Figure 7**. During Period V, synthetic materials such as high-density polyethylene (HDPE) and polypropylene were developed into new products, such as corrugated pipe, geomembranes, and geotextiles, that were promptly put to use on embankment dams where judged appropriate. New types of equipment related to these new materials and products were developed, and quality control tests, testing equipment, and detailed test procedures were developed, with Reclamation's significant participation in these developments.
